Twigworth Green

Follow-Up Report of Dead or Damaged Saplings & General Landscaping

28 March 2026

Cllr John Redfern - Twigworth Parish Council

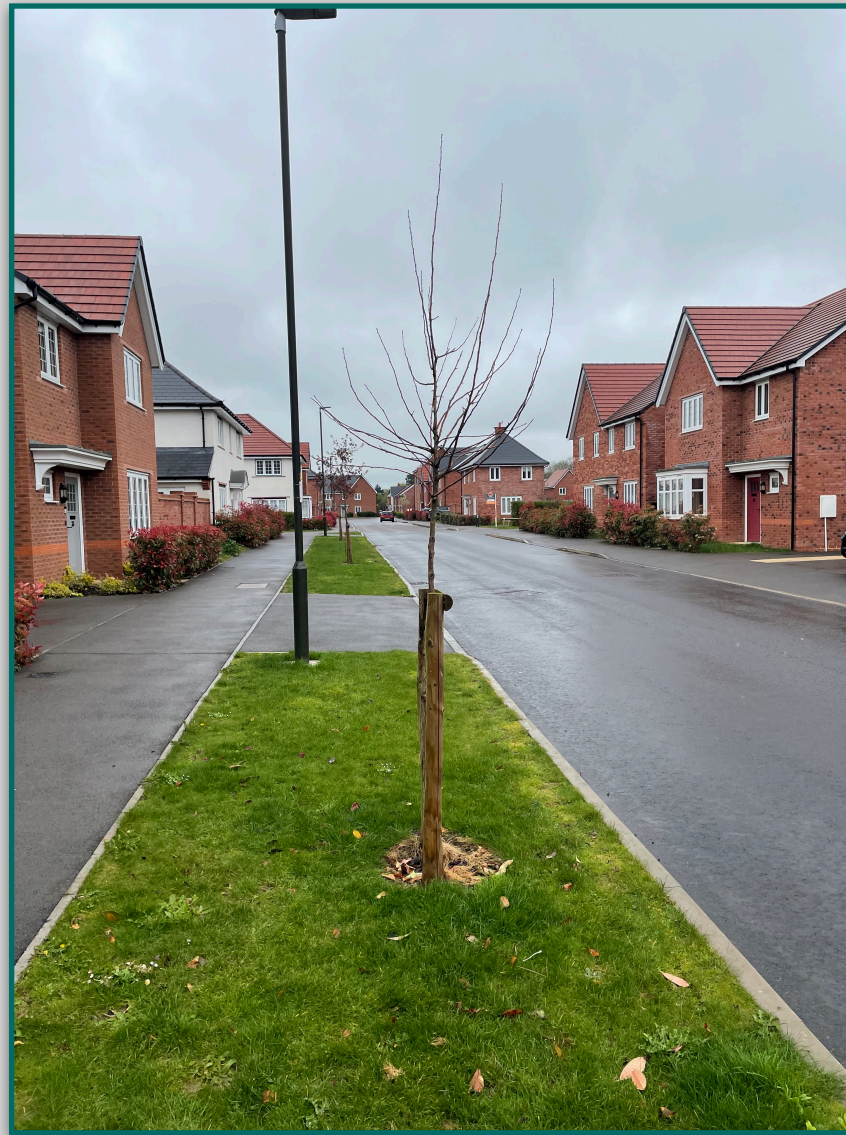
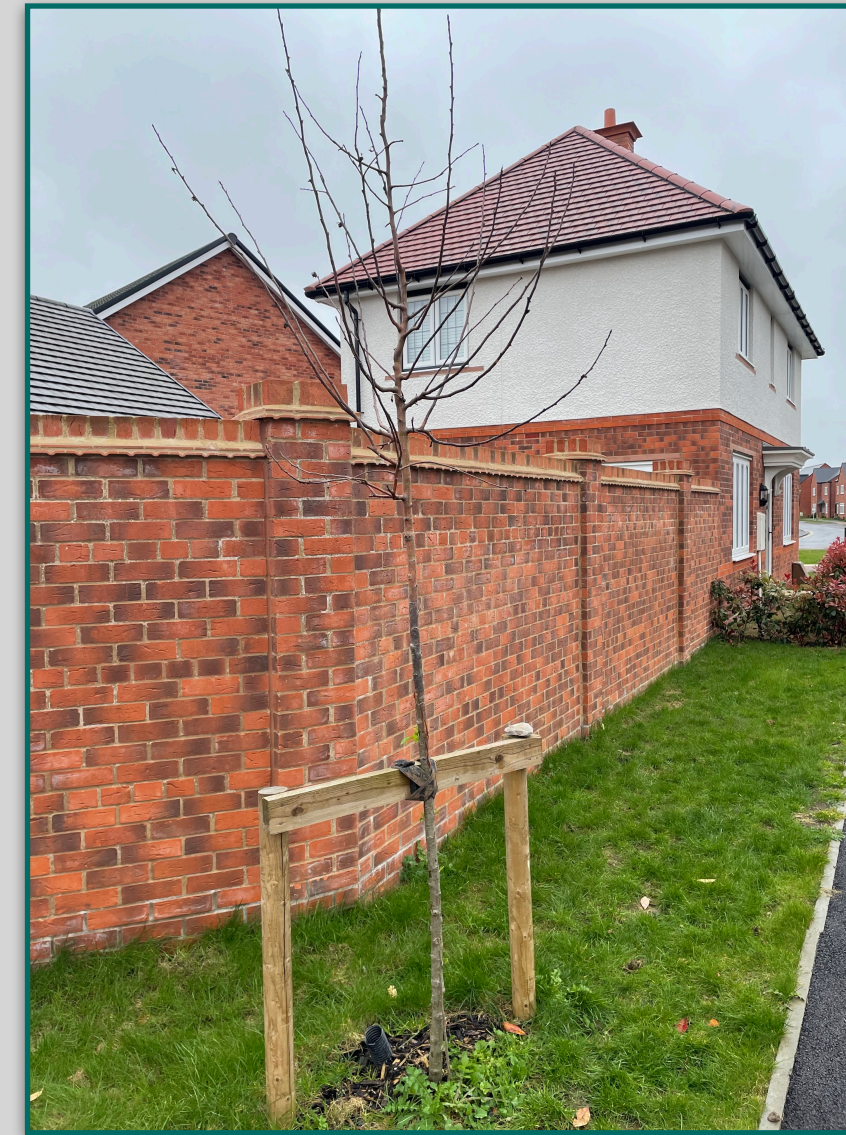
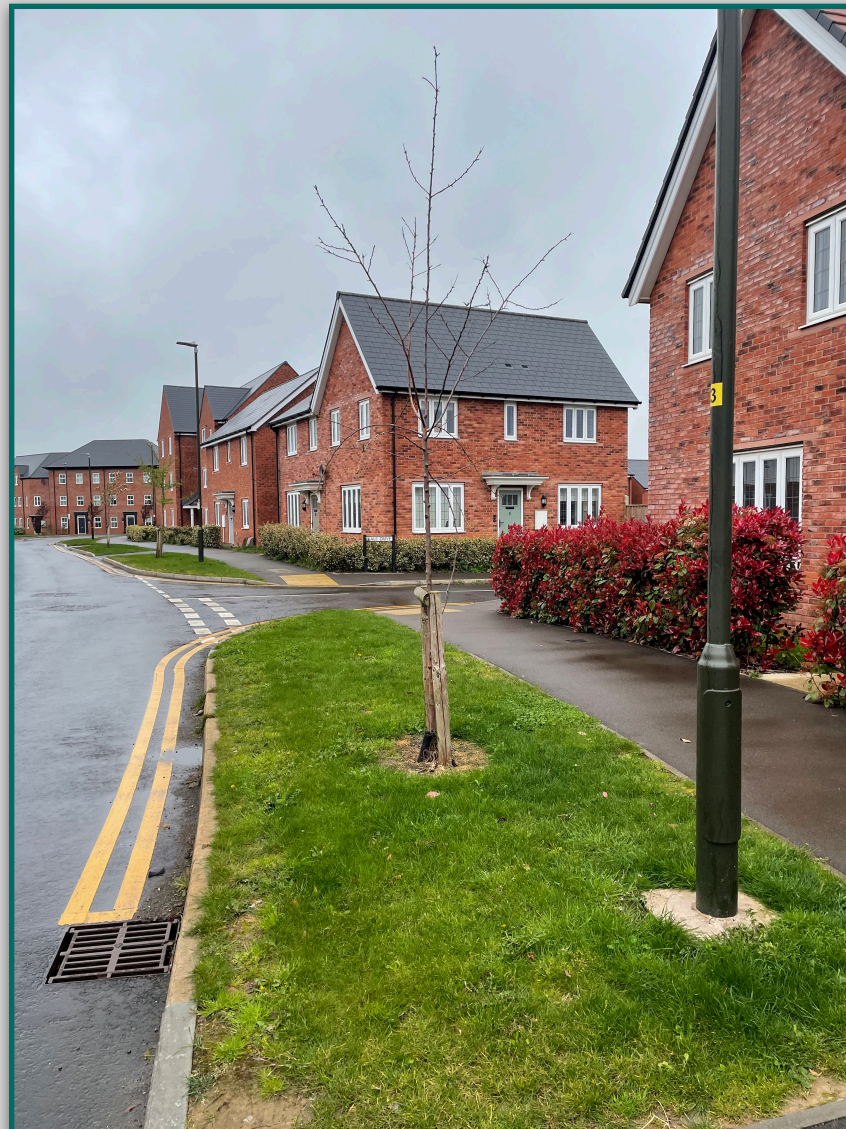
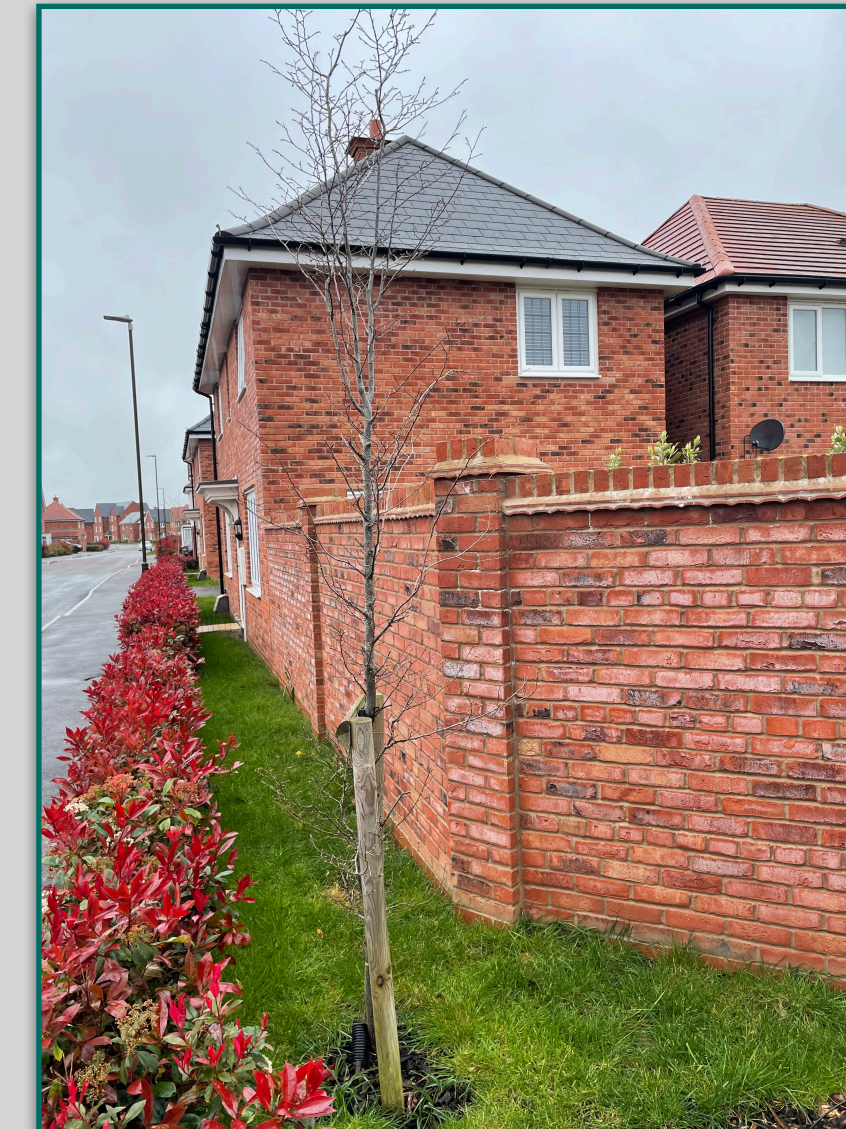
Broken Trees

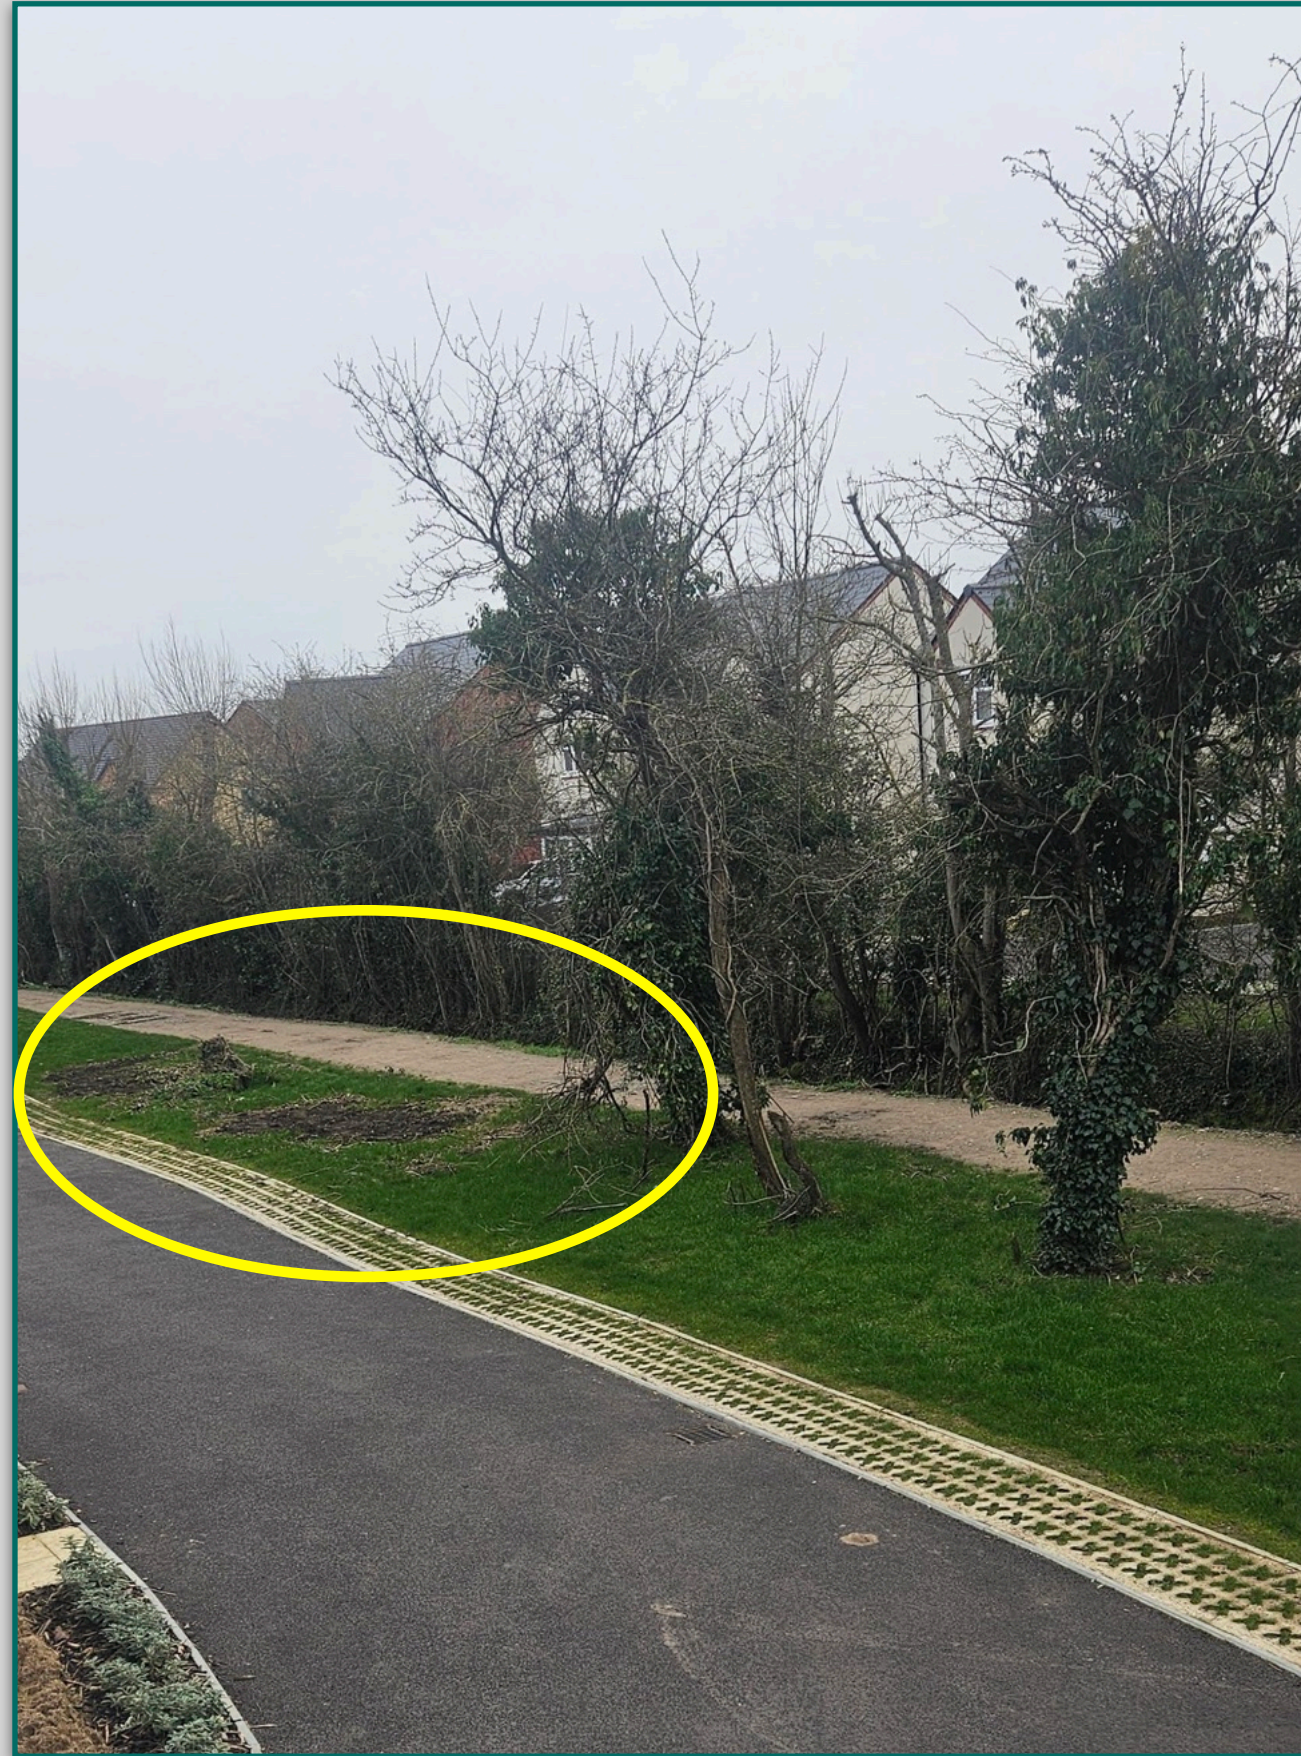
Elderberry Gardens - Bridle

Dead Trees

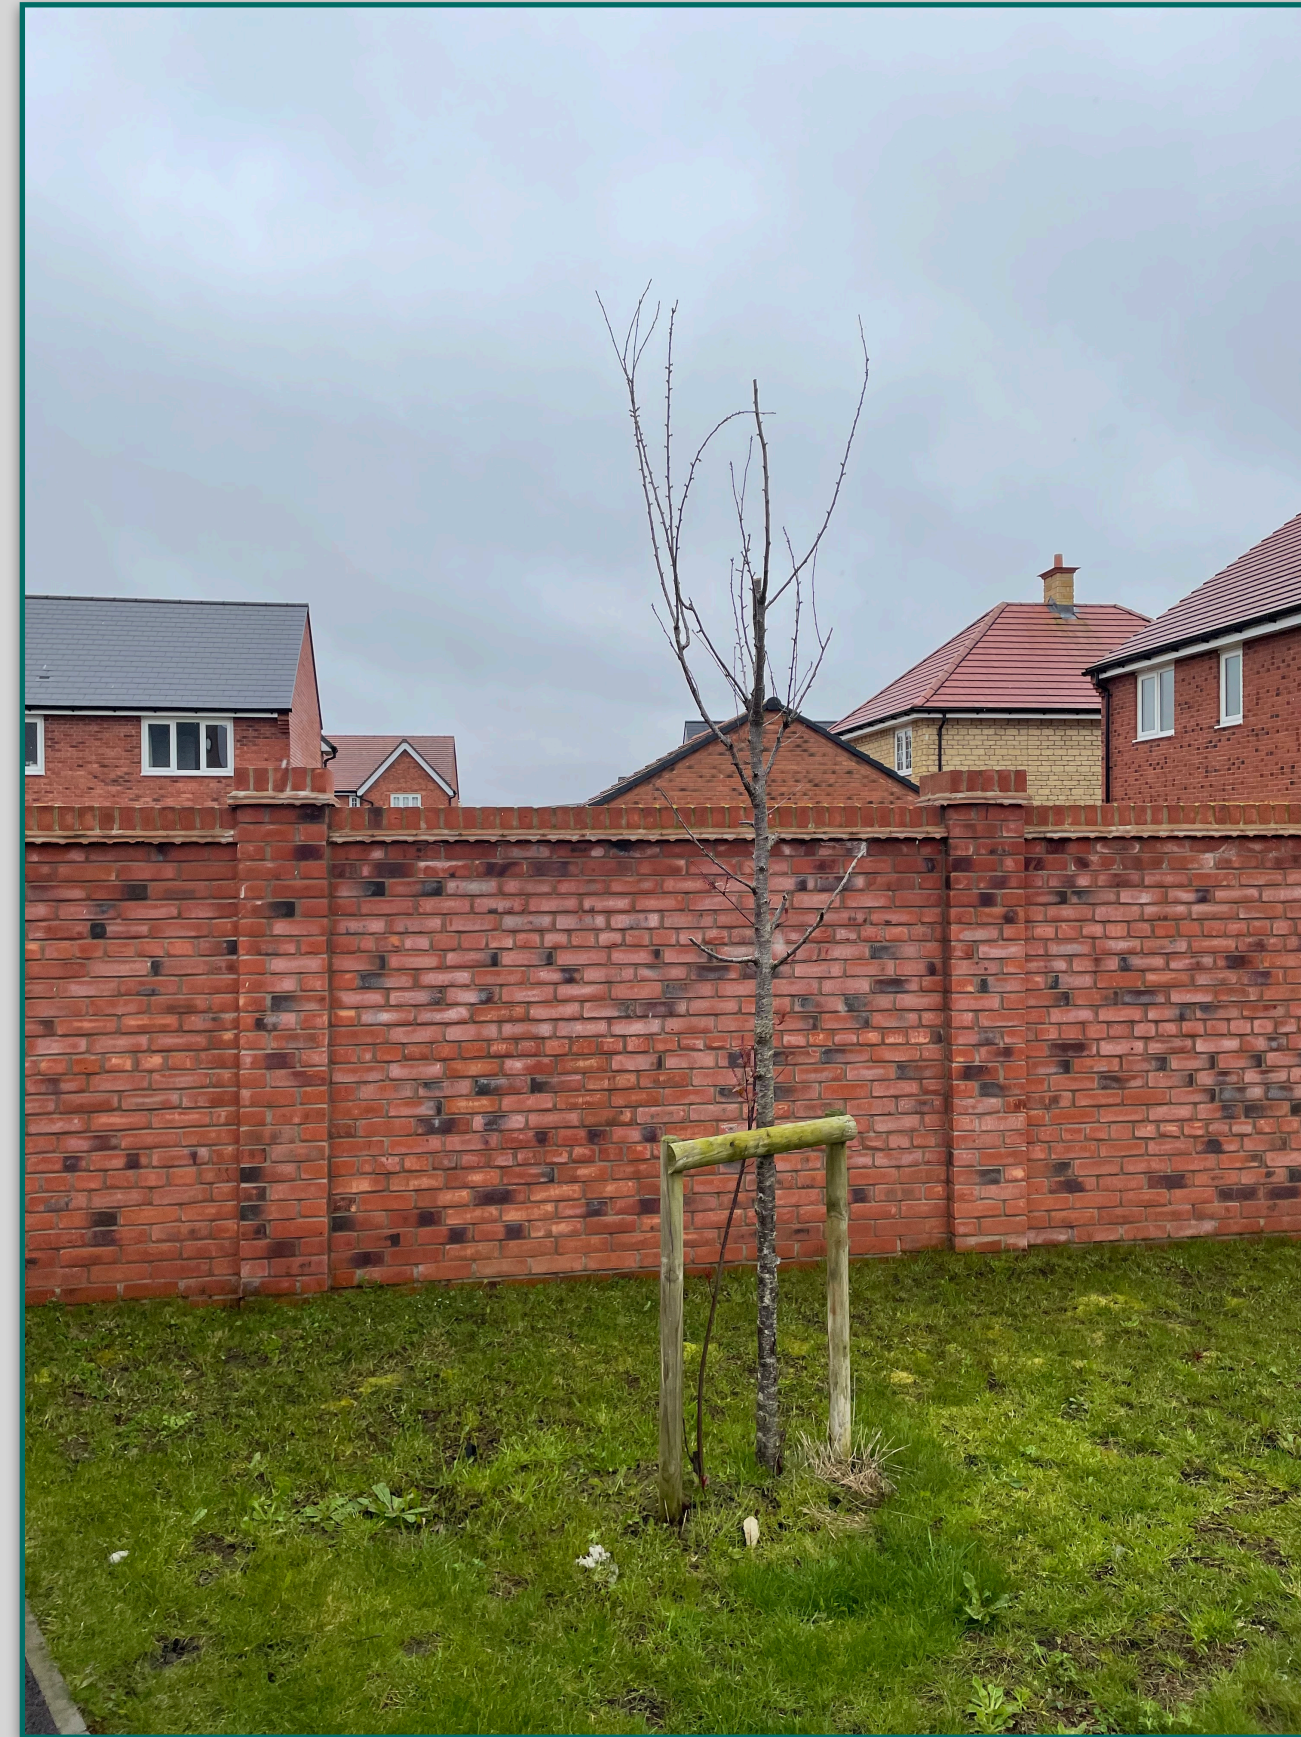
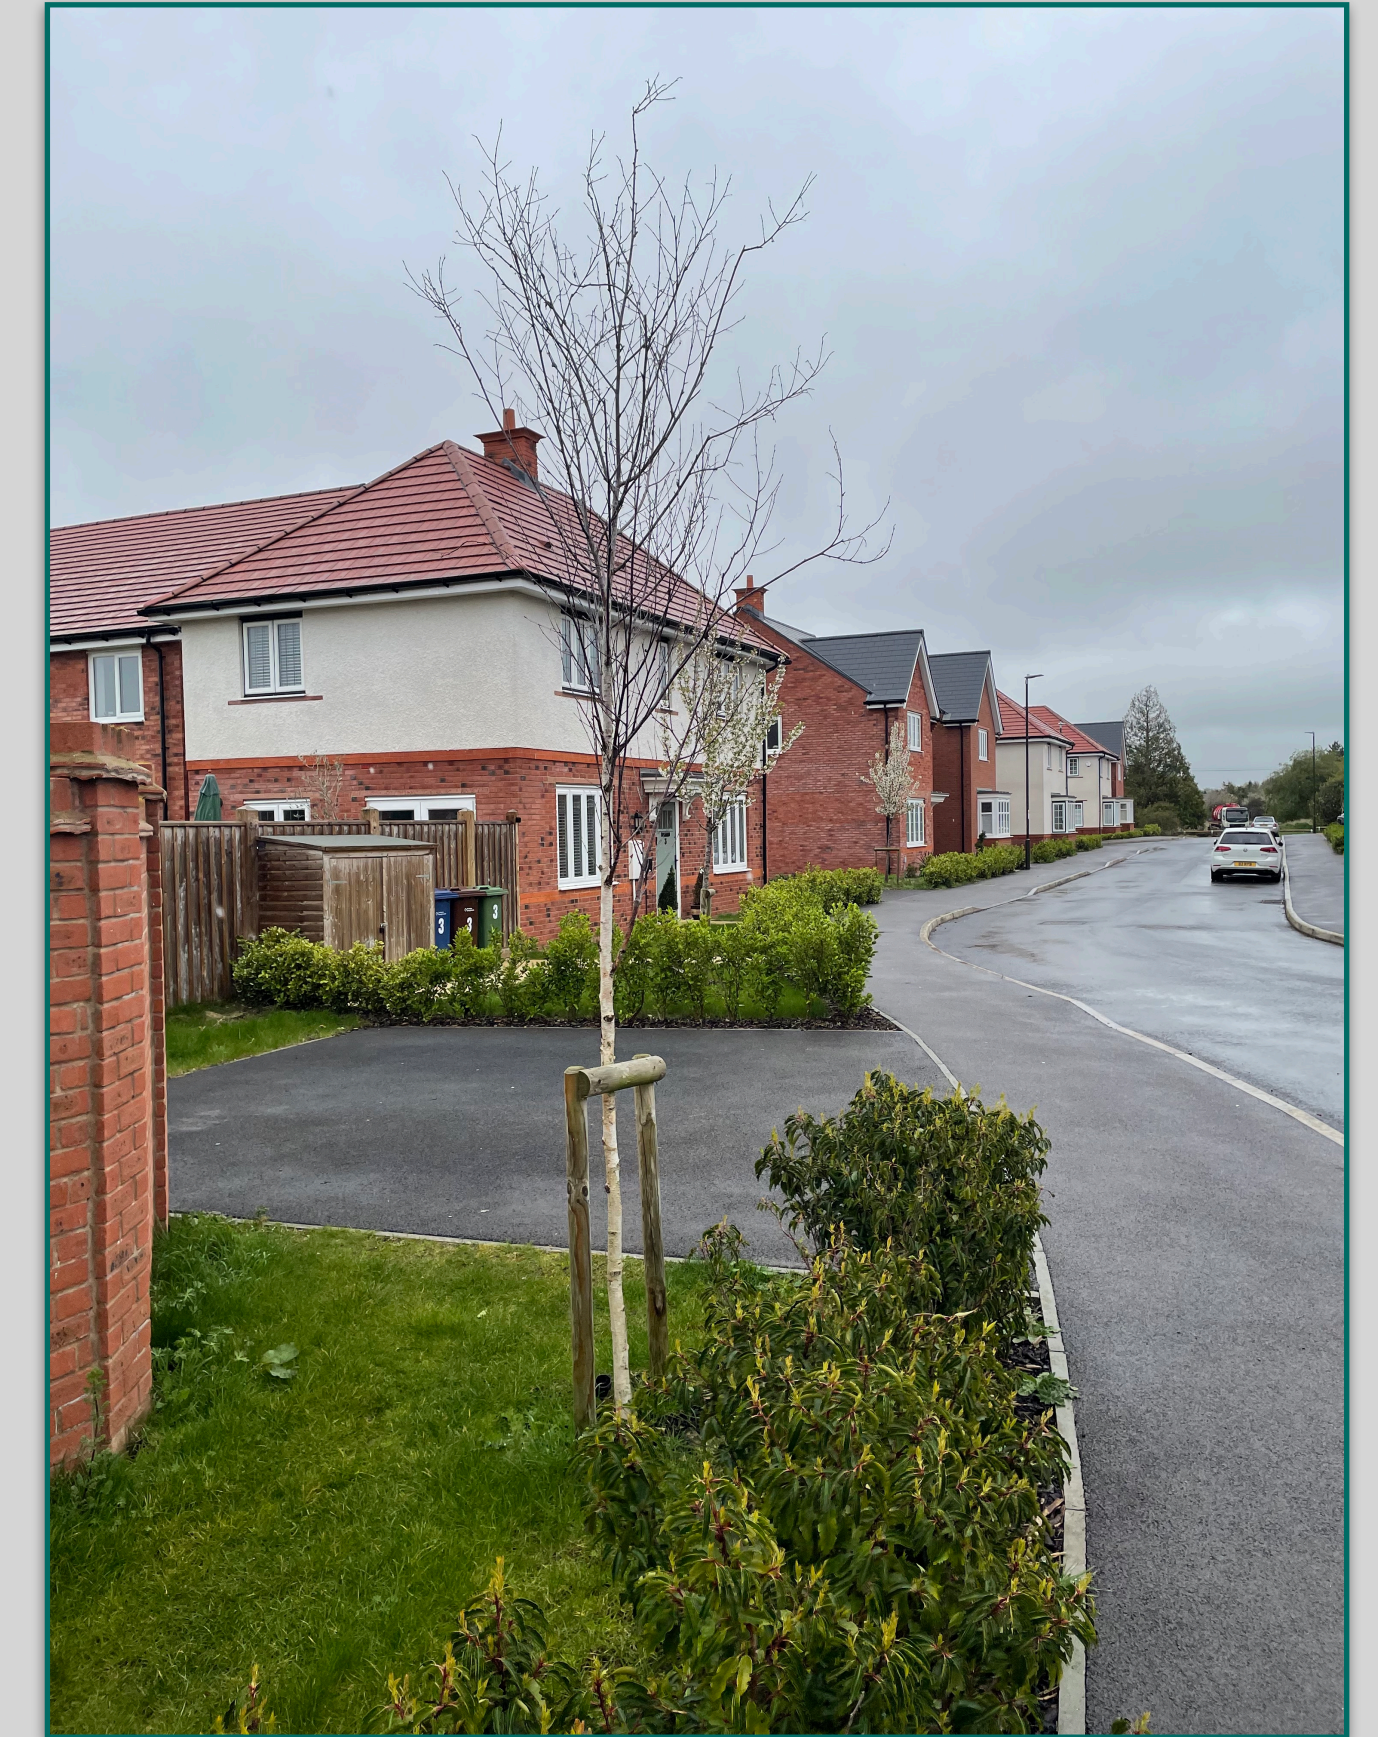
Sorrell Street

Missing Trees

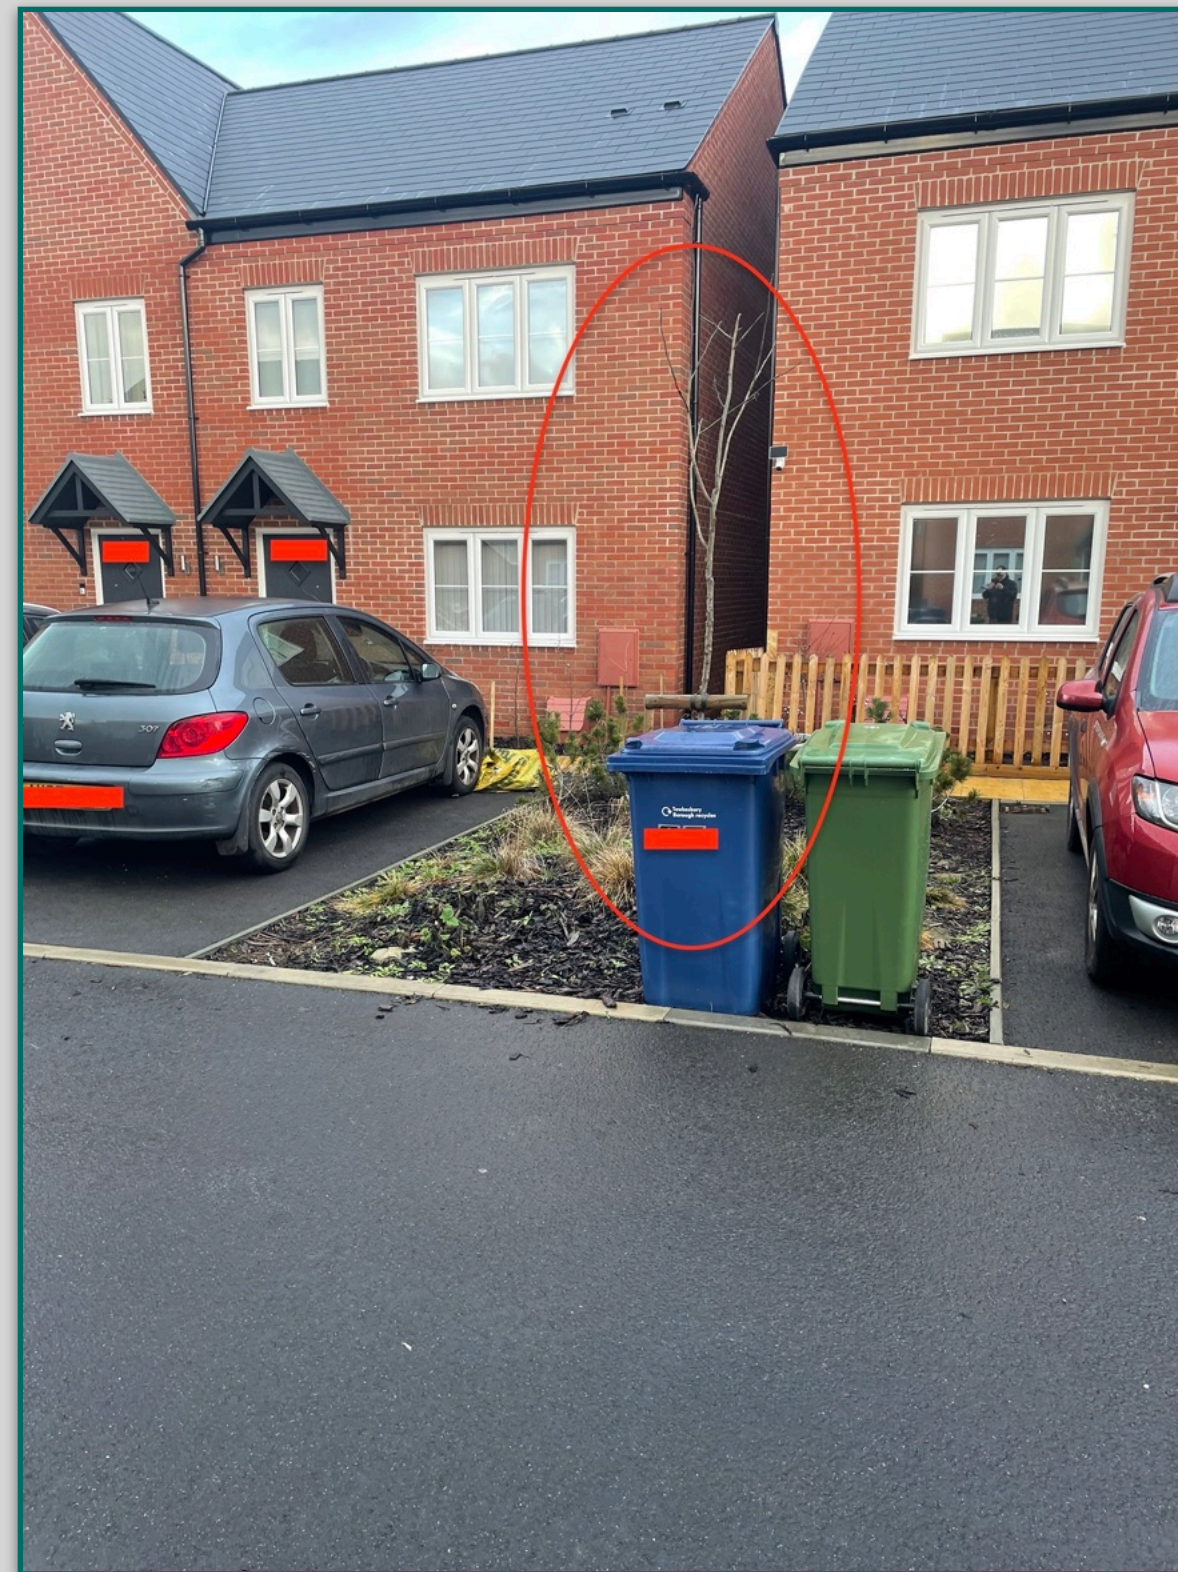
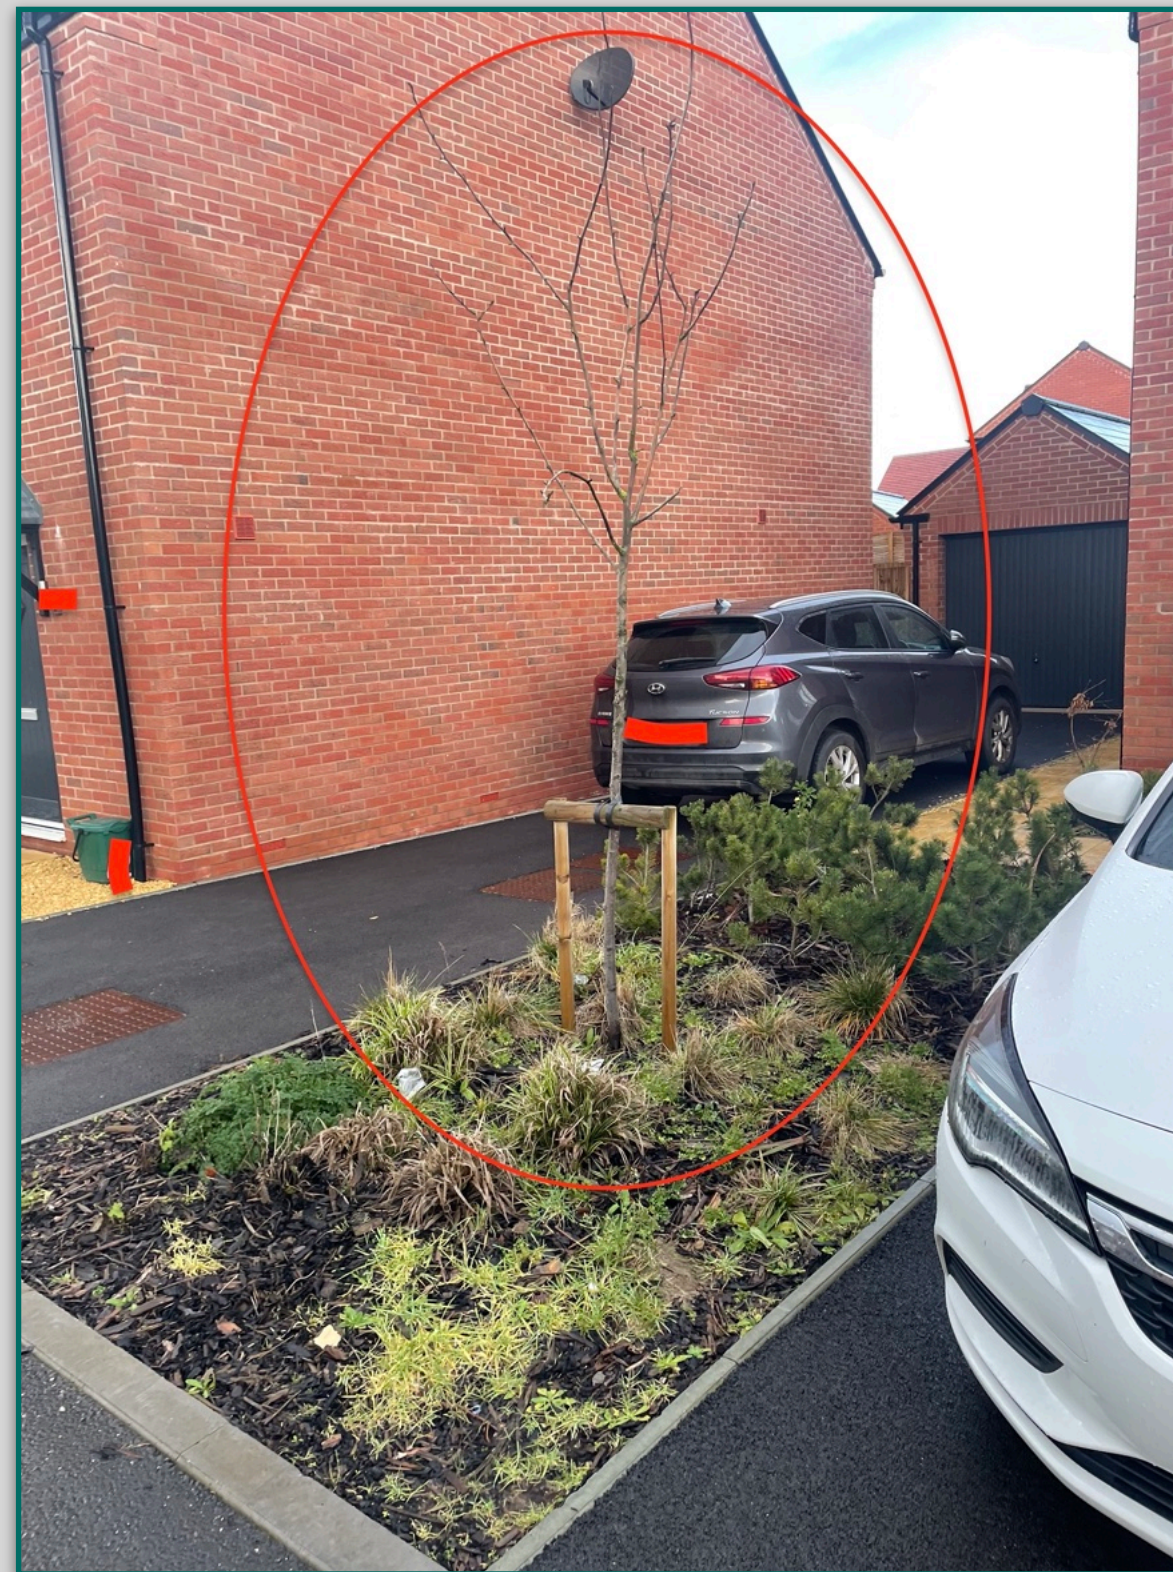
Weaver Crescent

Dead Trees

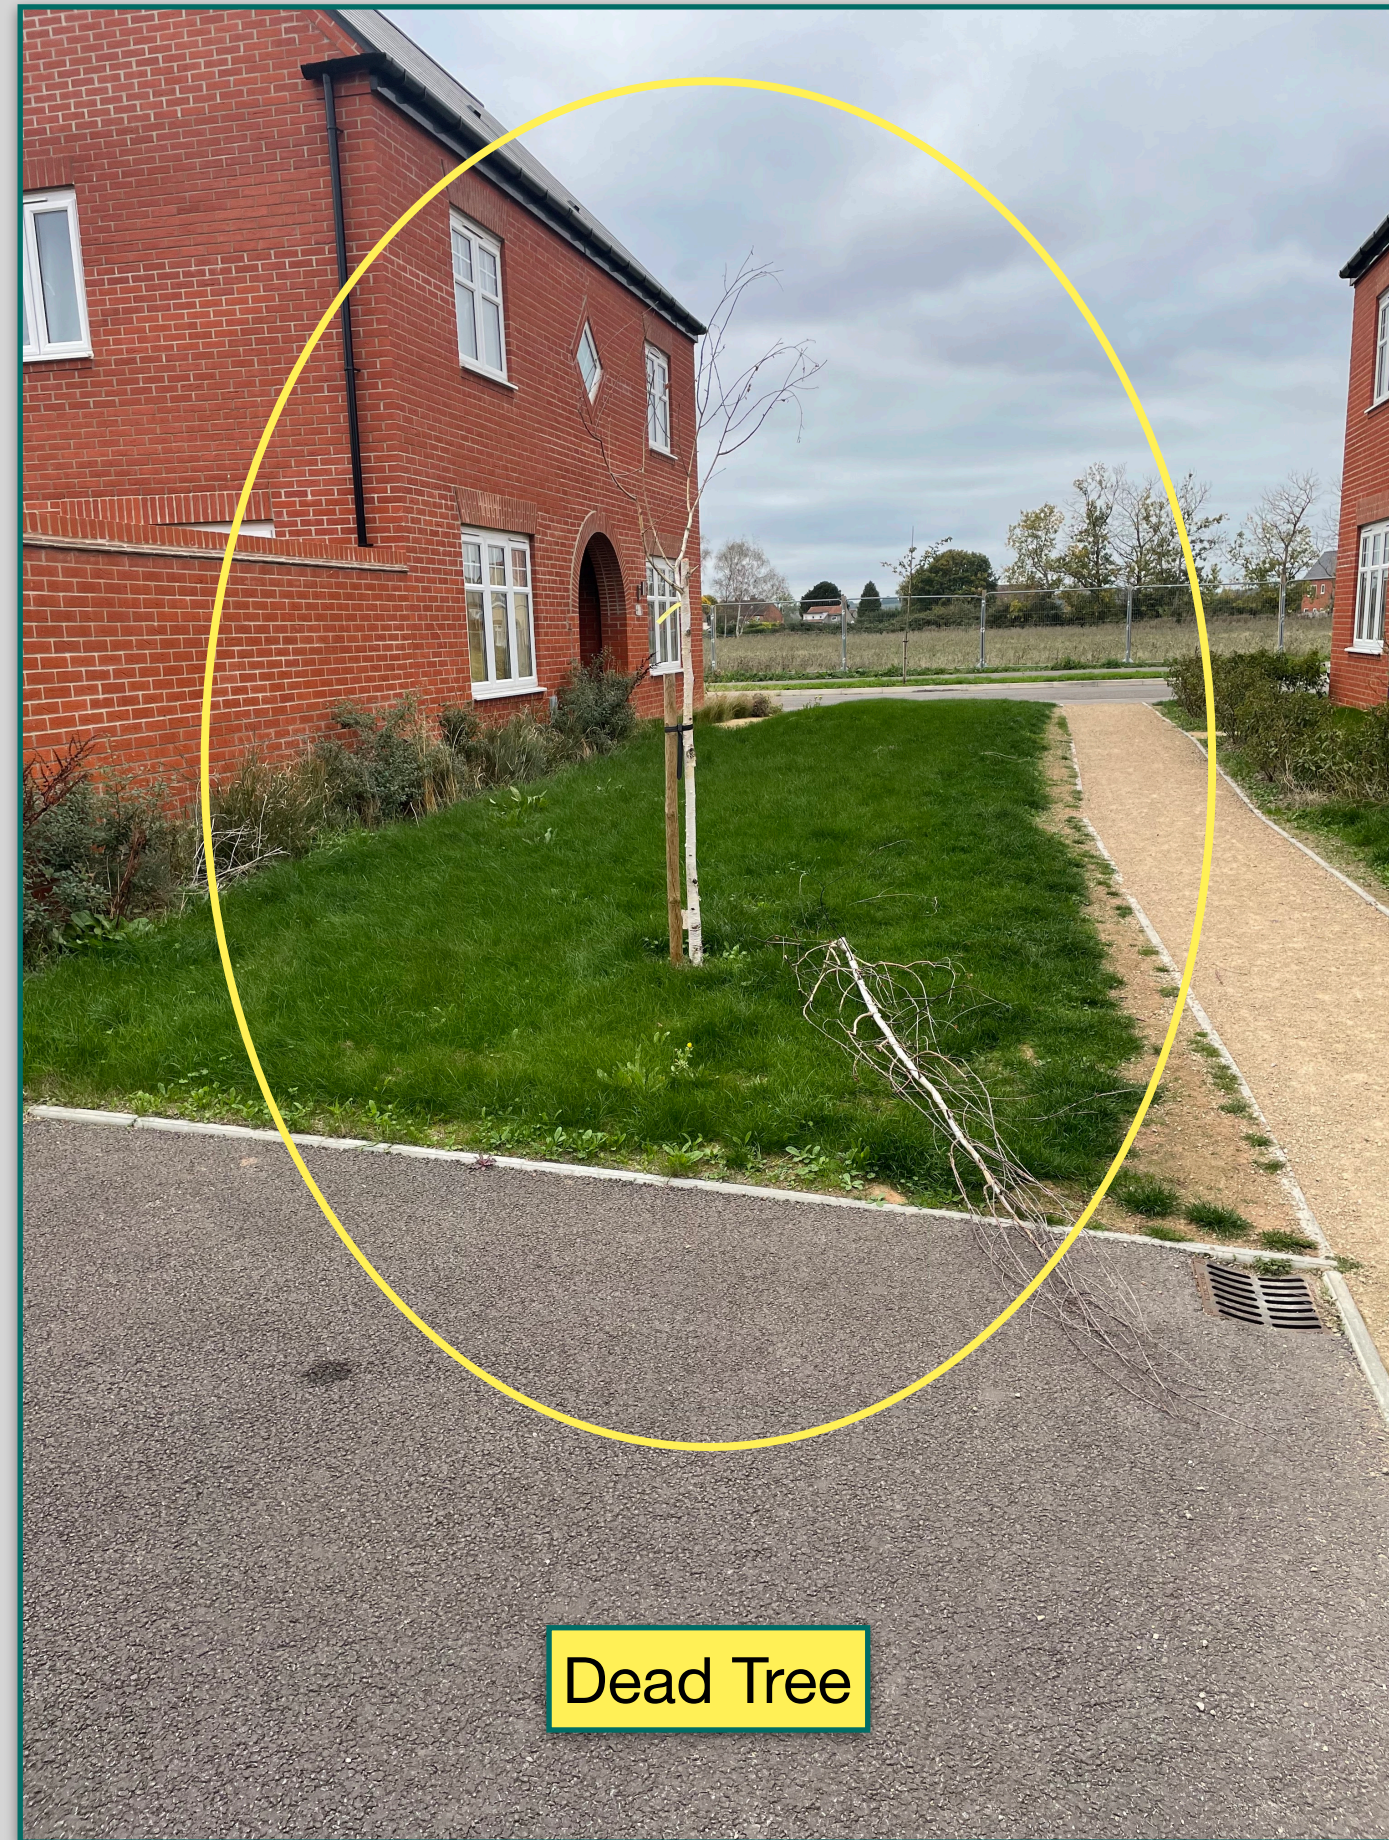
Halfpenny Close

Dead Trees

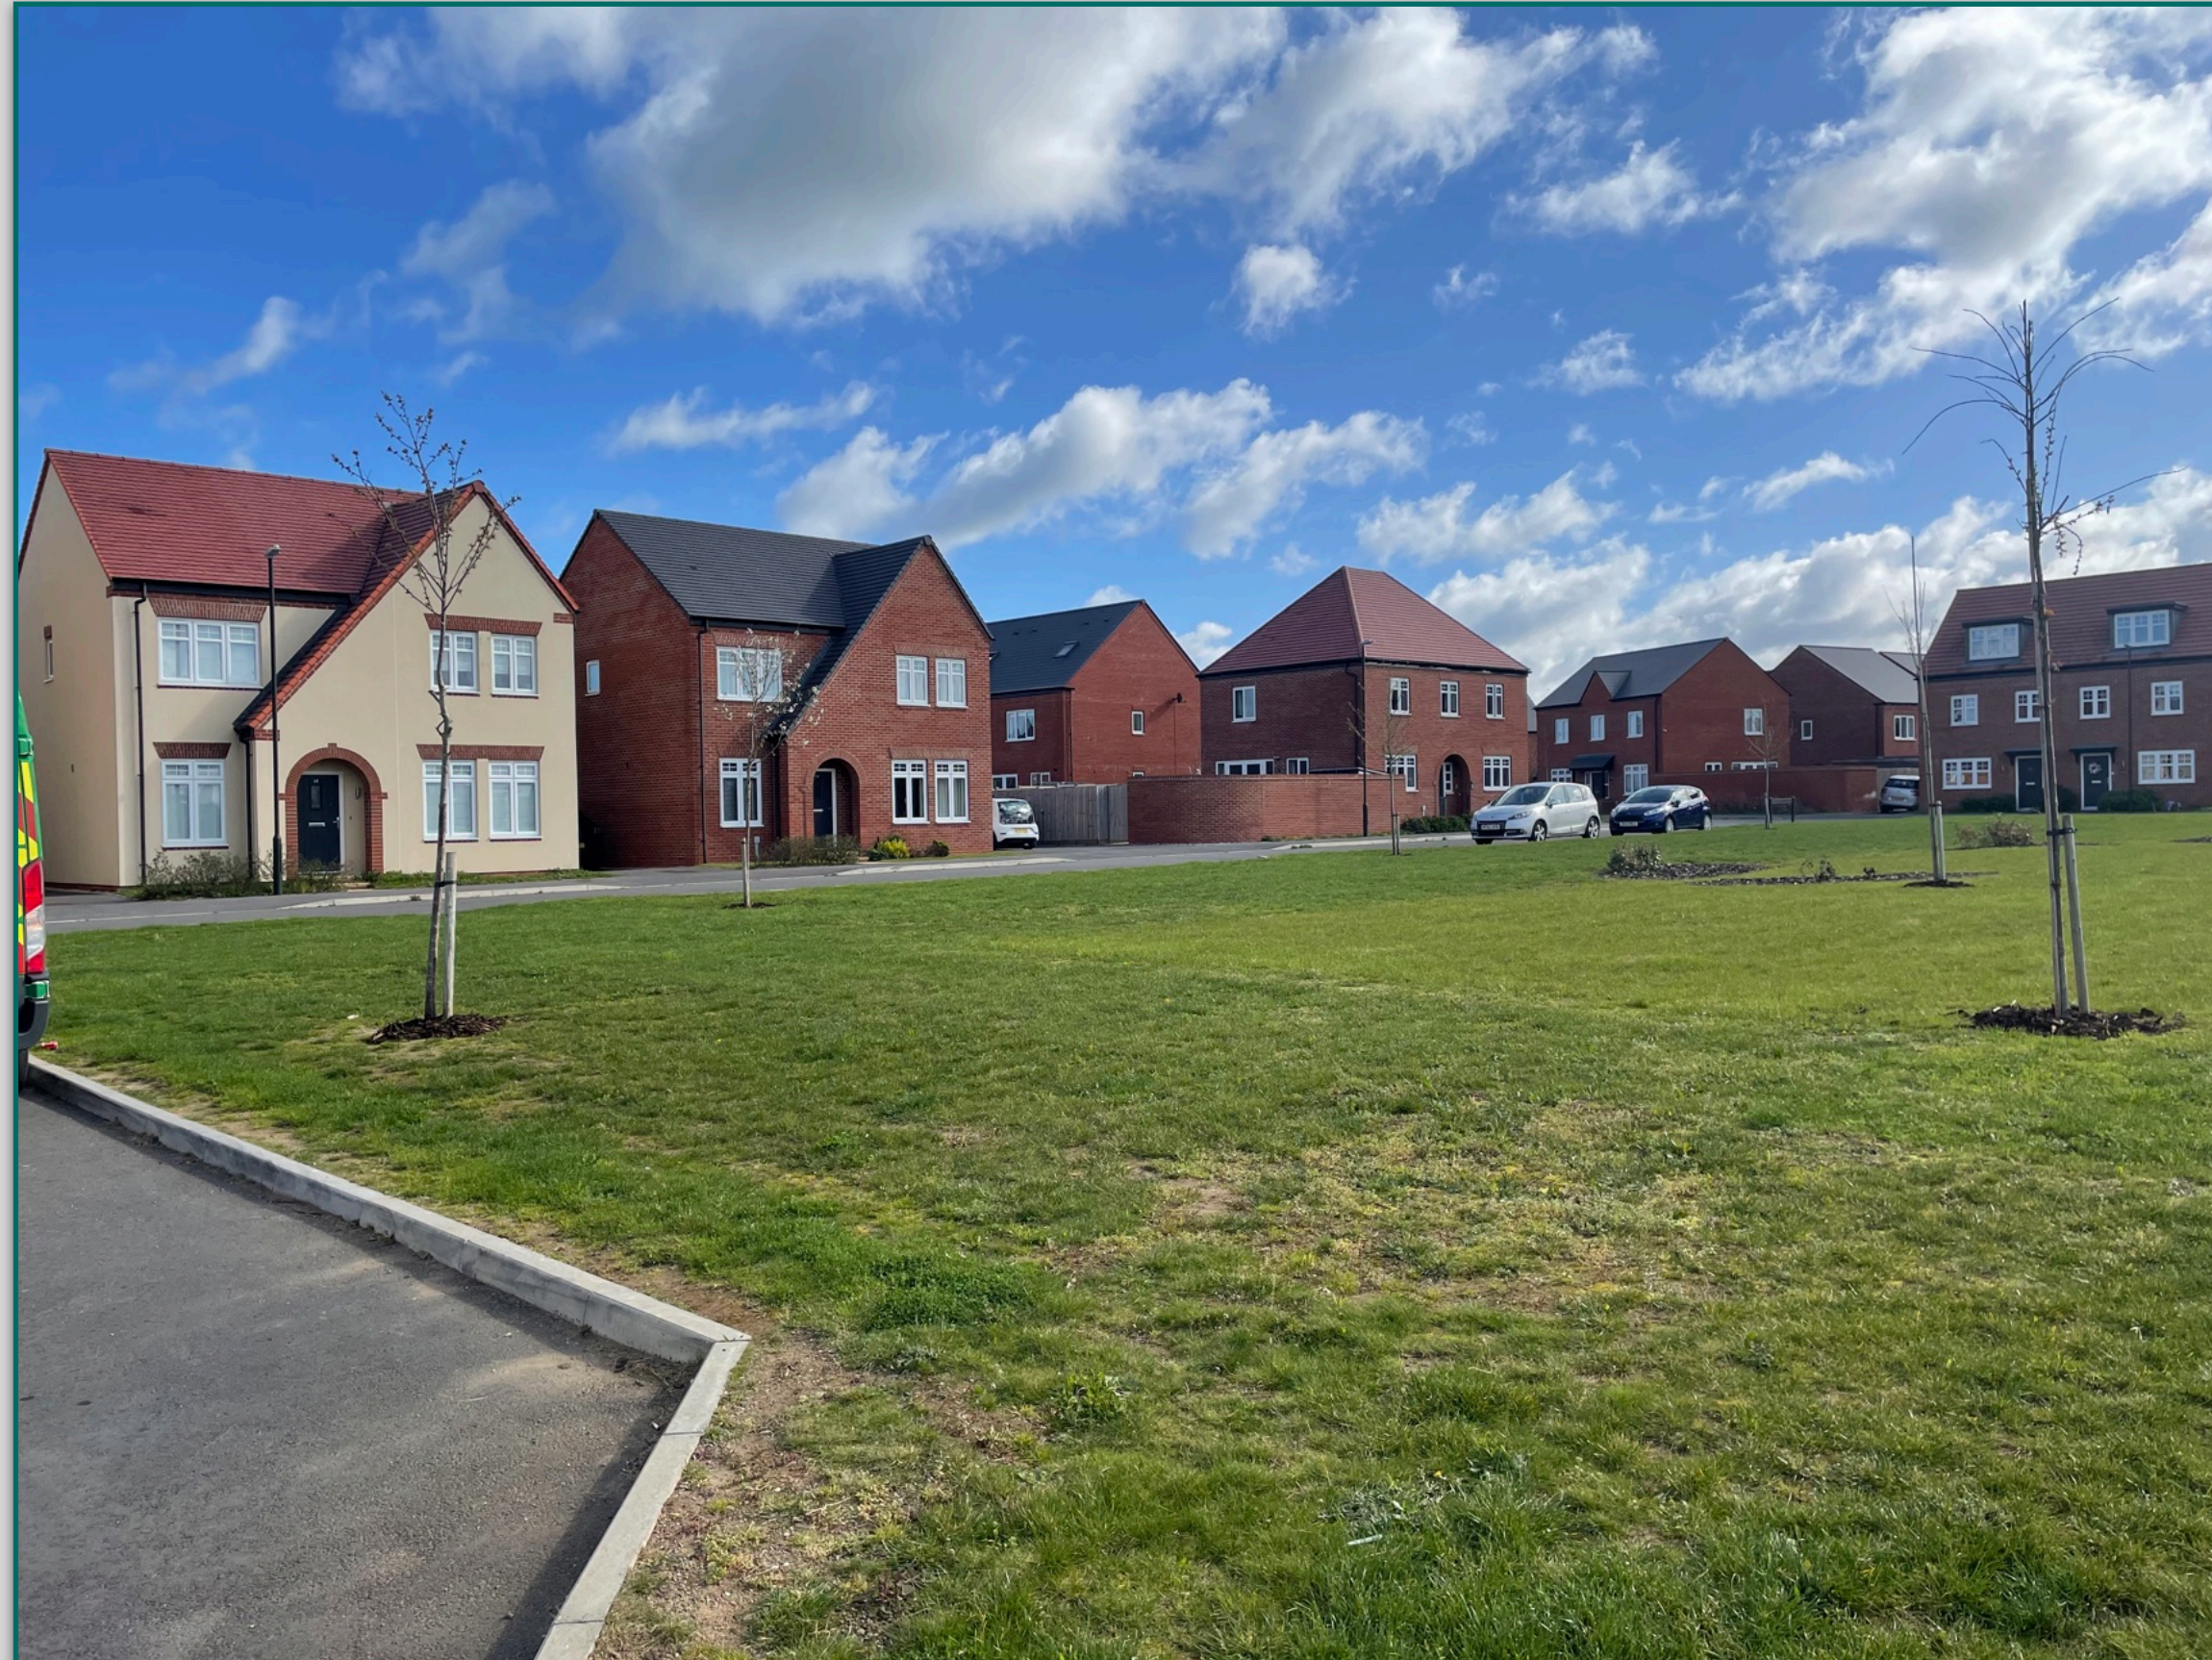
Comfrey Gardens

The trees do not look to be healthy and should be inspected.

The shrub areas also look to be in a poor state and should be inspected

The grass areas are patchy due to poor seeding

There were parts of this land that were never seeded and just left
