Twigworth Green

Follow-Up Report of Dead or Damaged Saplings & General Landscaping

28 March 2026

Cllr John Redfern - Twigworth Parish Council

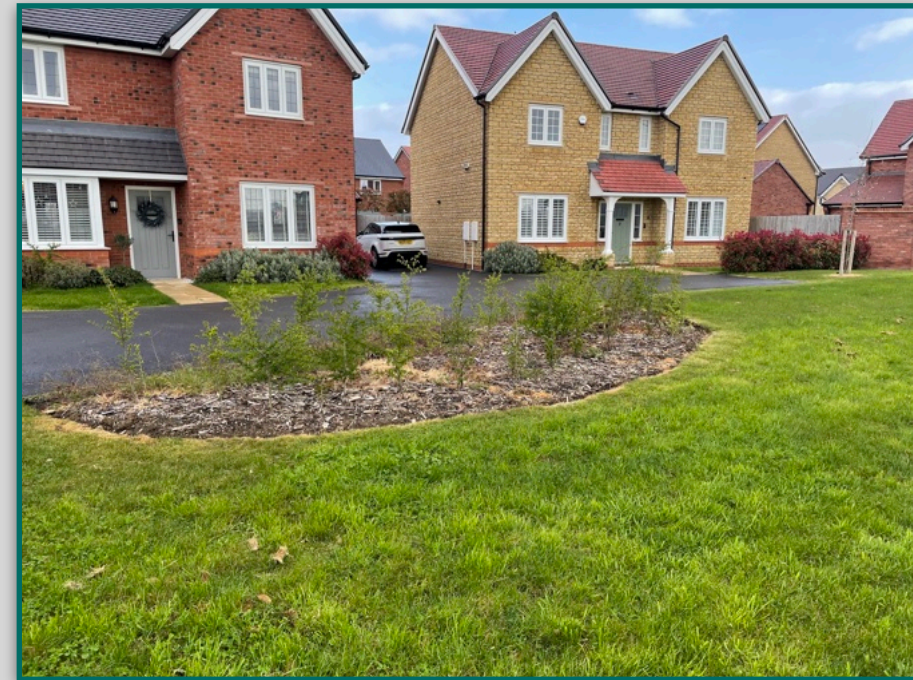
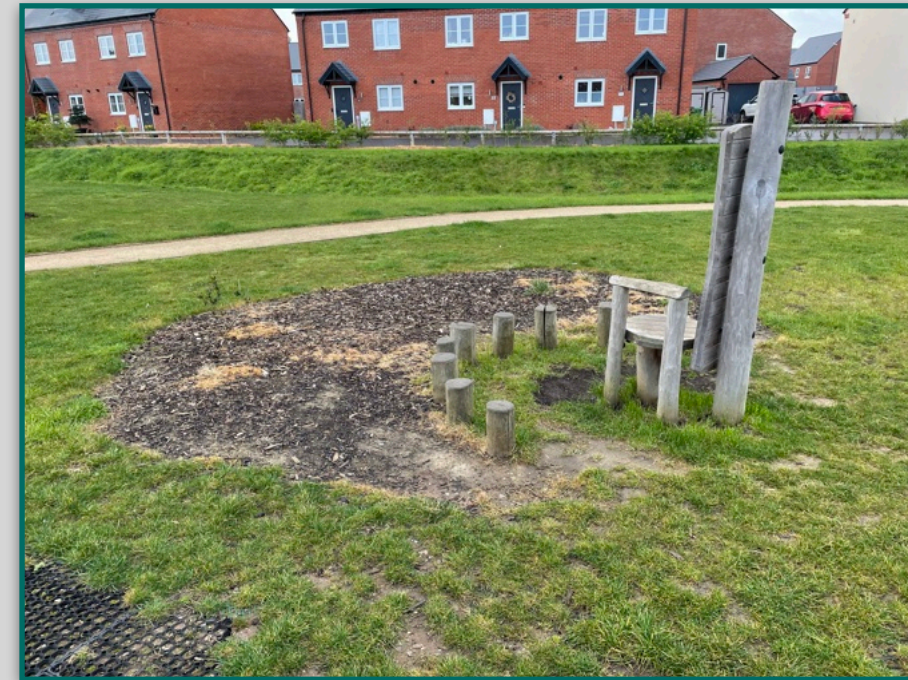
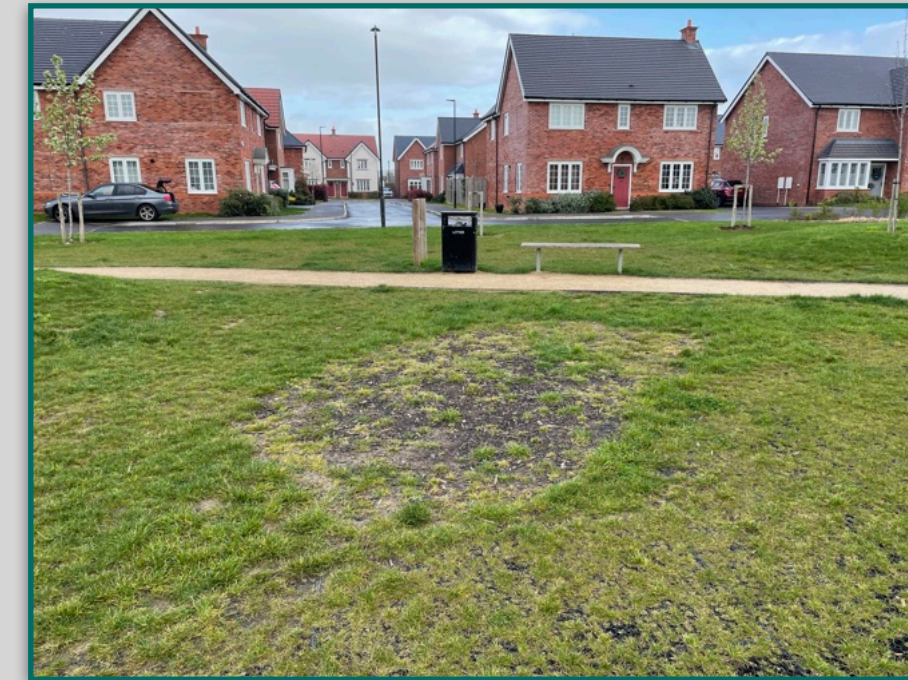
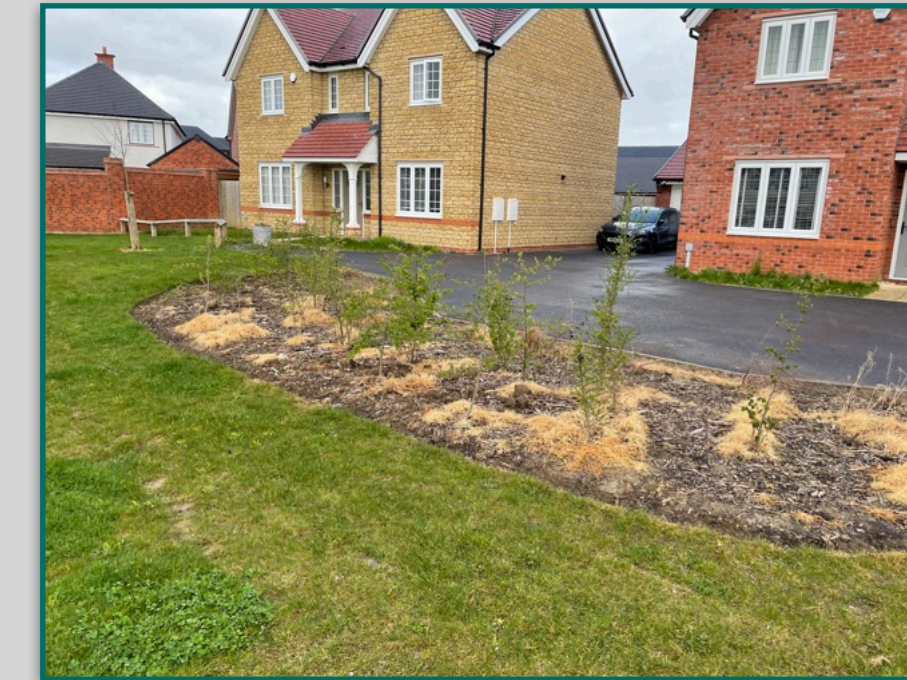
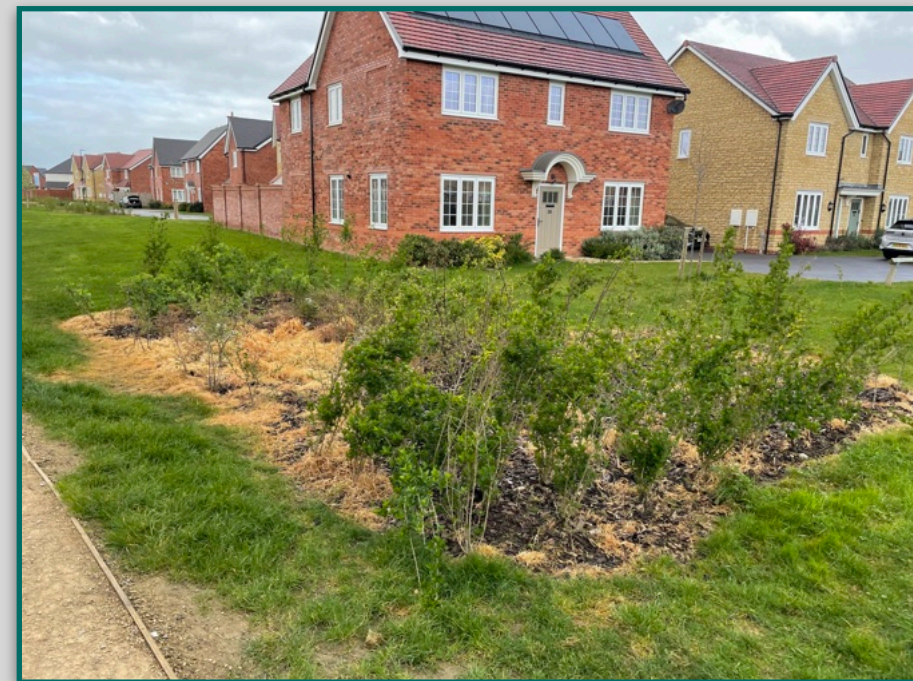
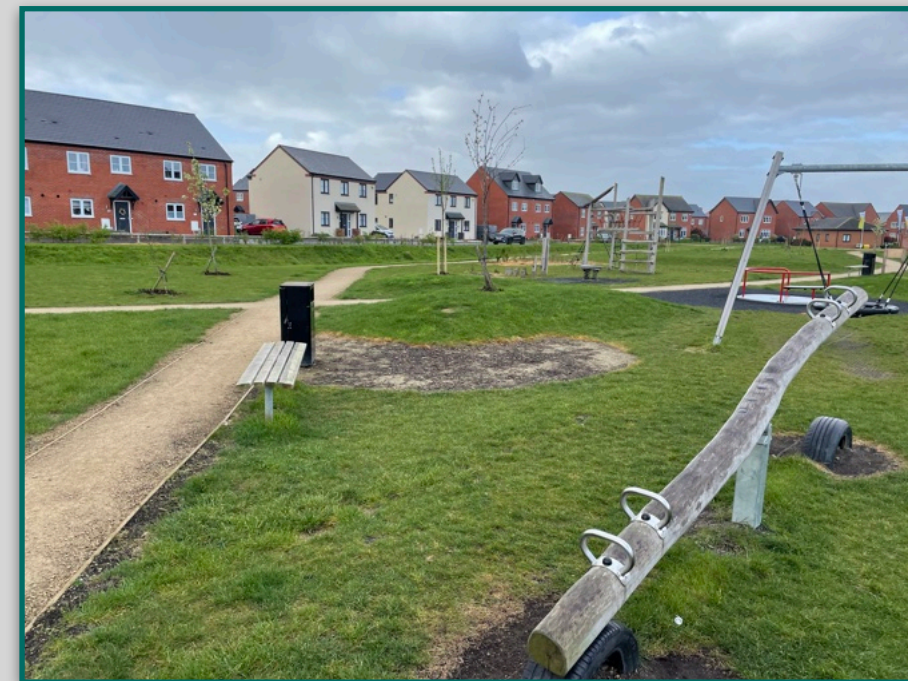
Play Area & Green

Poor maintenance of shrub areas

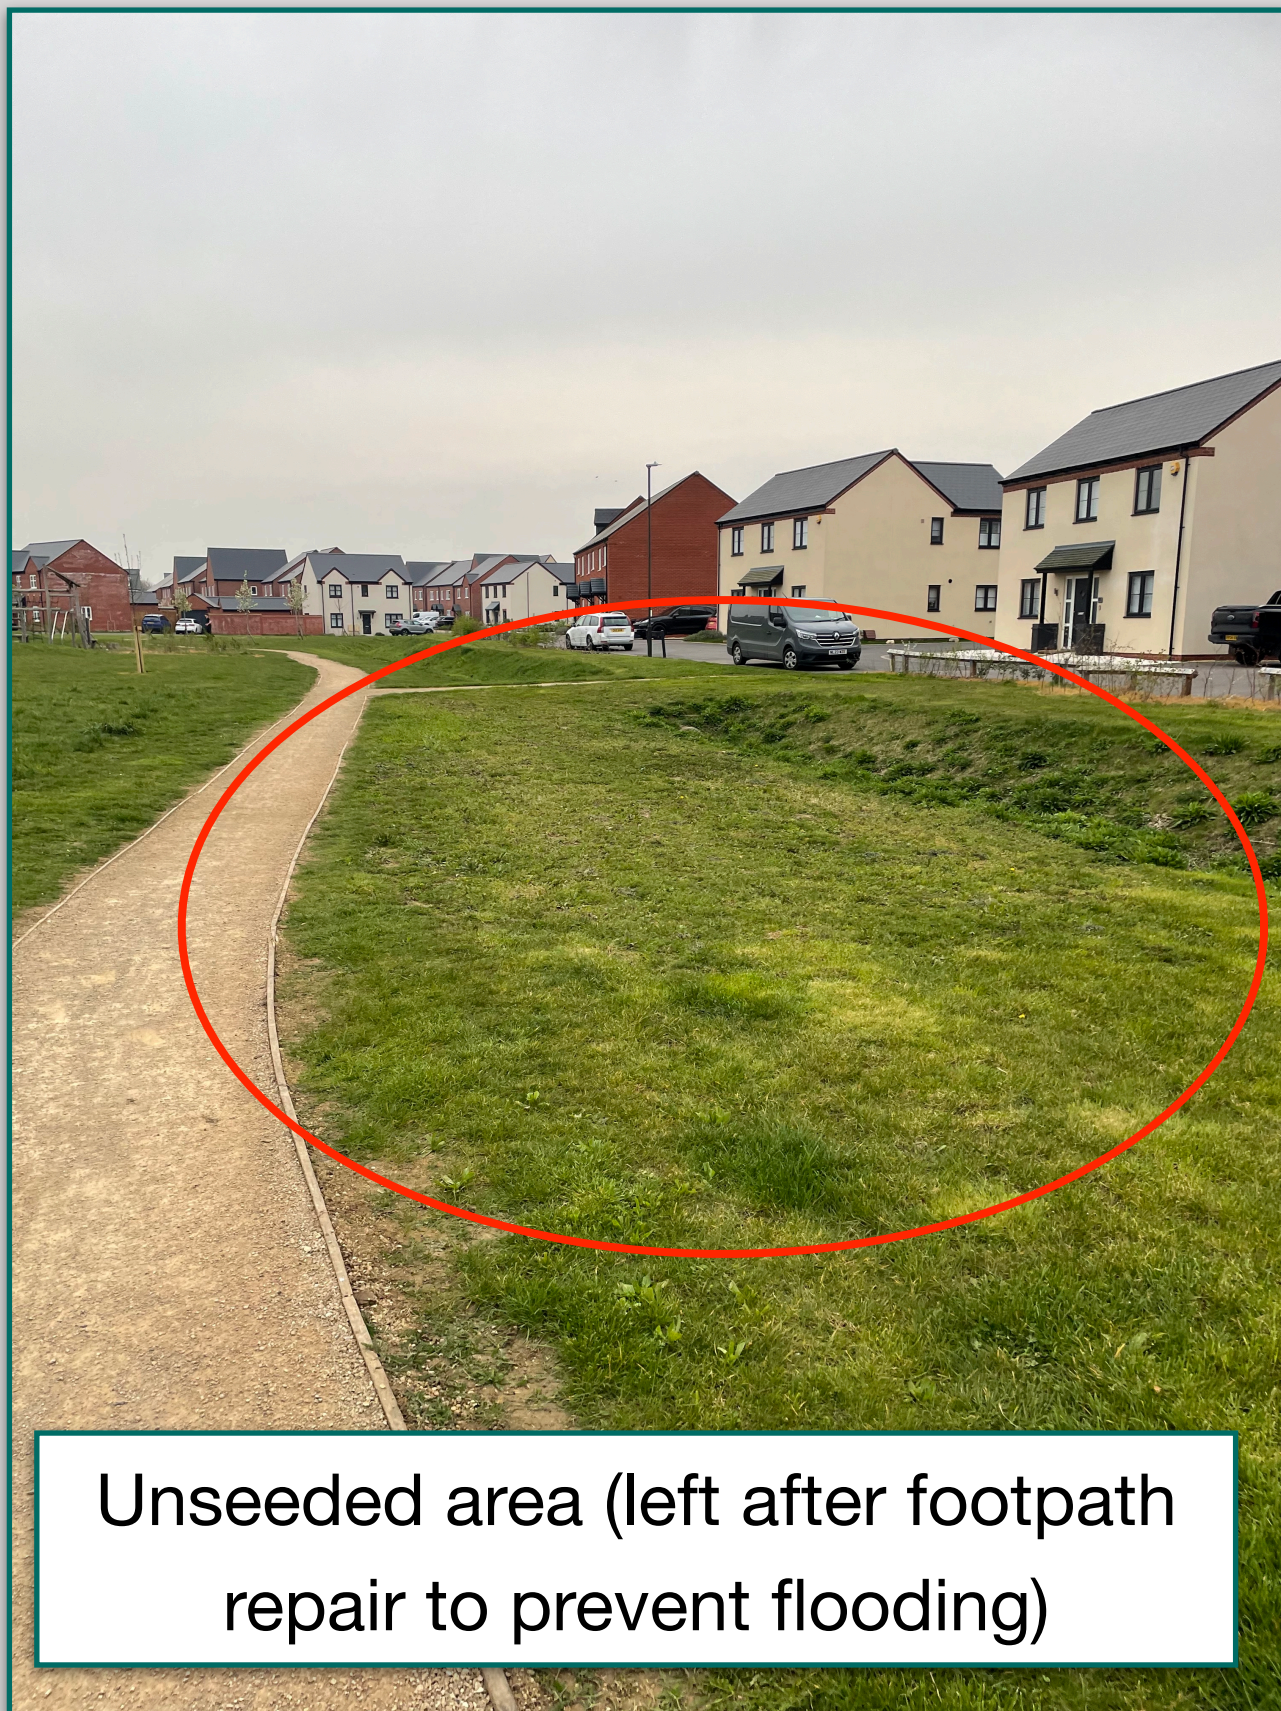
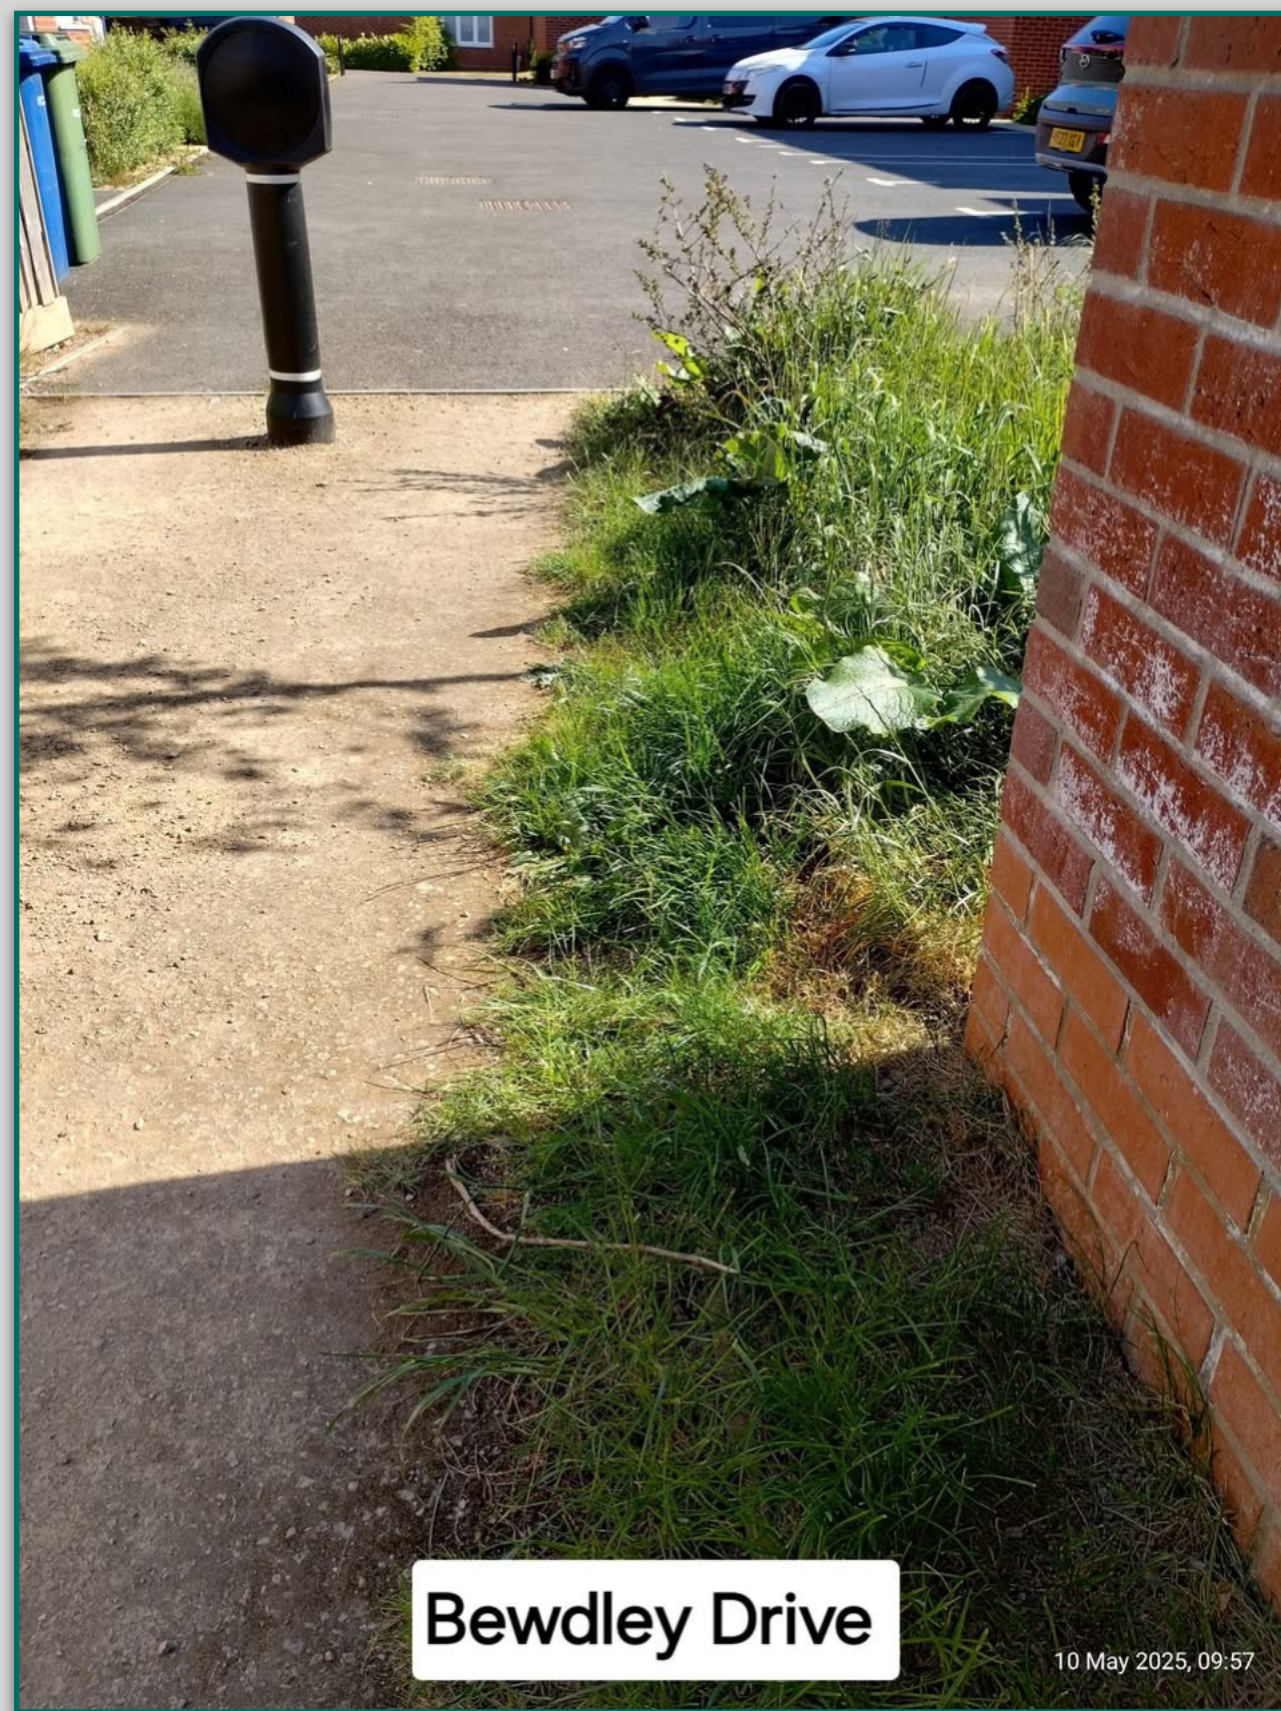
Poor Maintenance

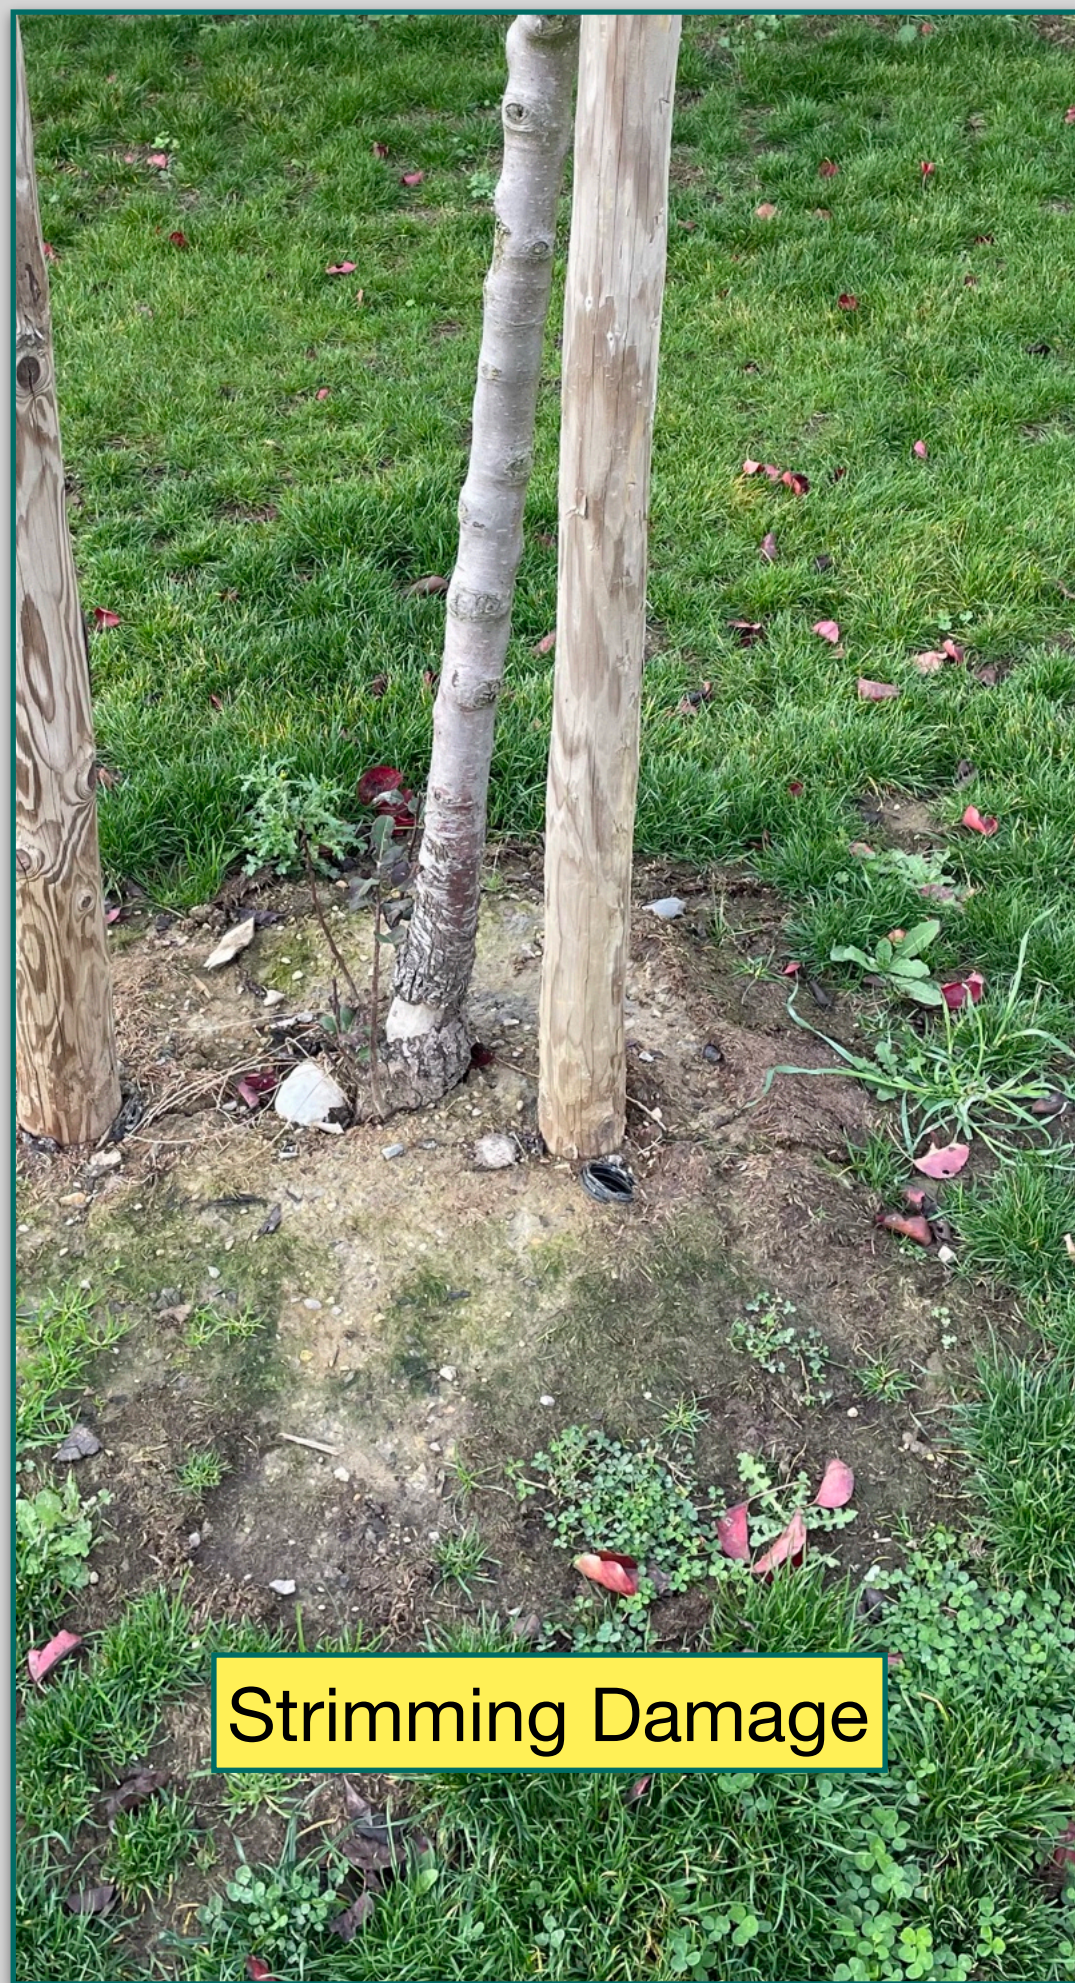
Poor Maintenance
