Twigworth Green

Follow-Up Report of Dead or Damaged Saplings & General Landscaping

22 April 2026

Cllr John Redfern - Twigworth Parish Council

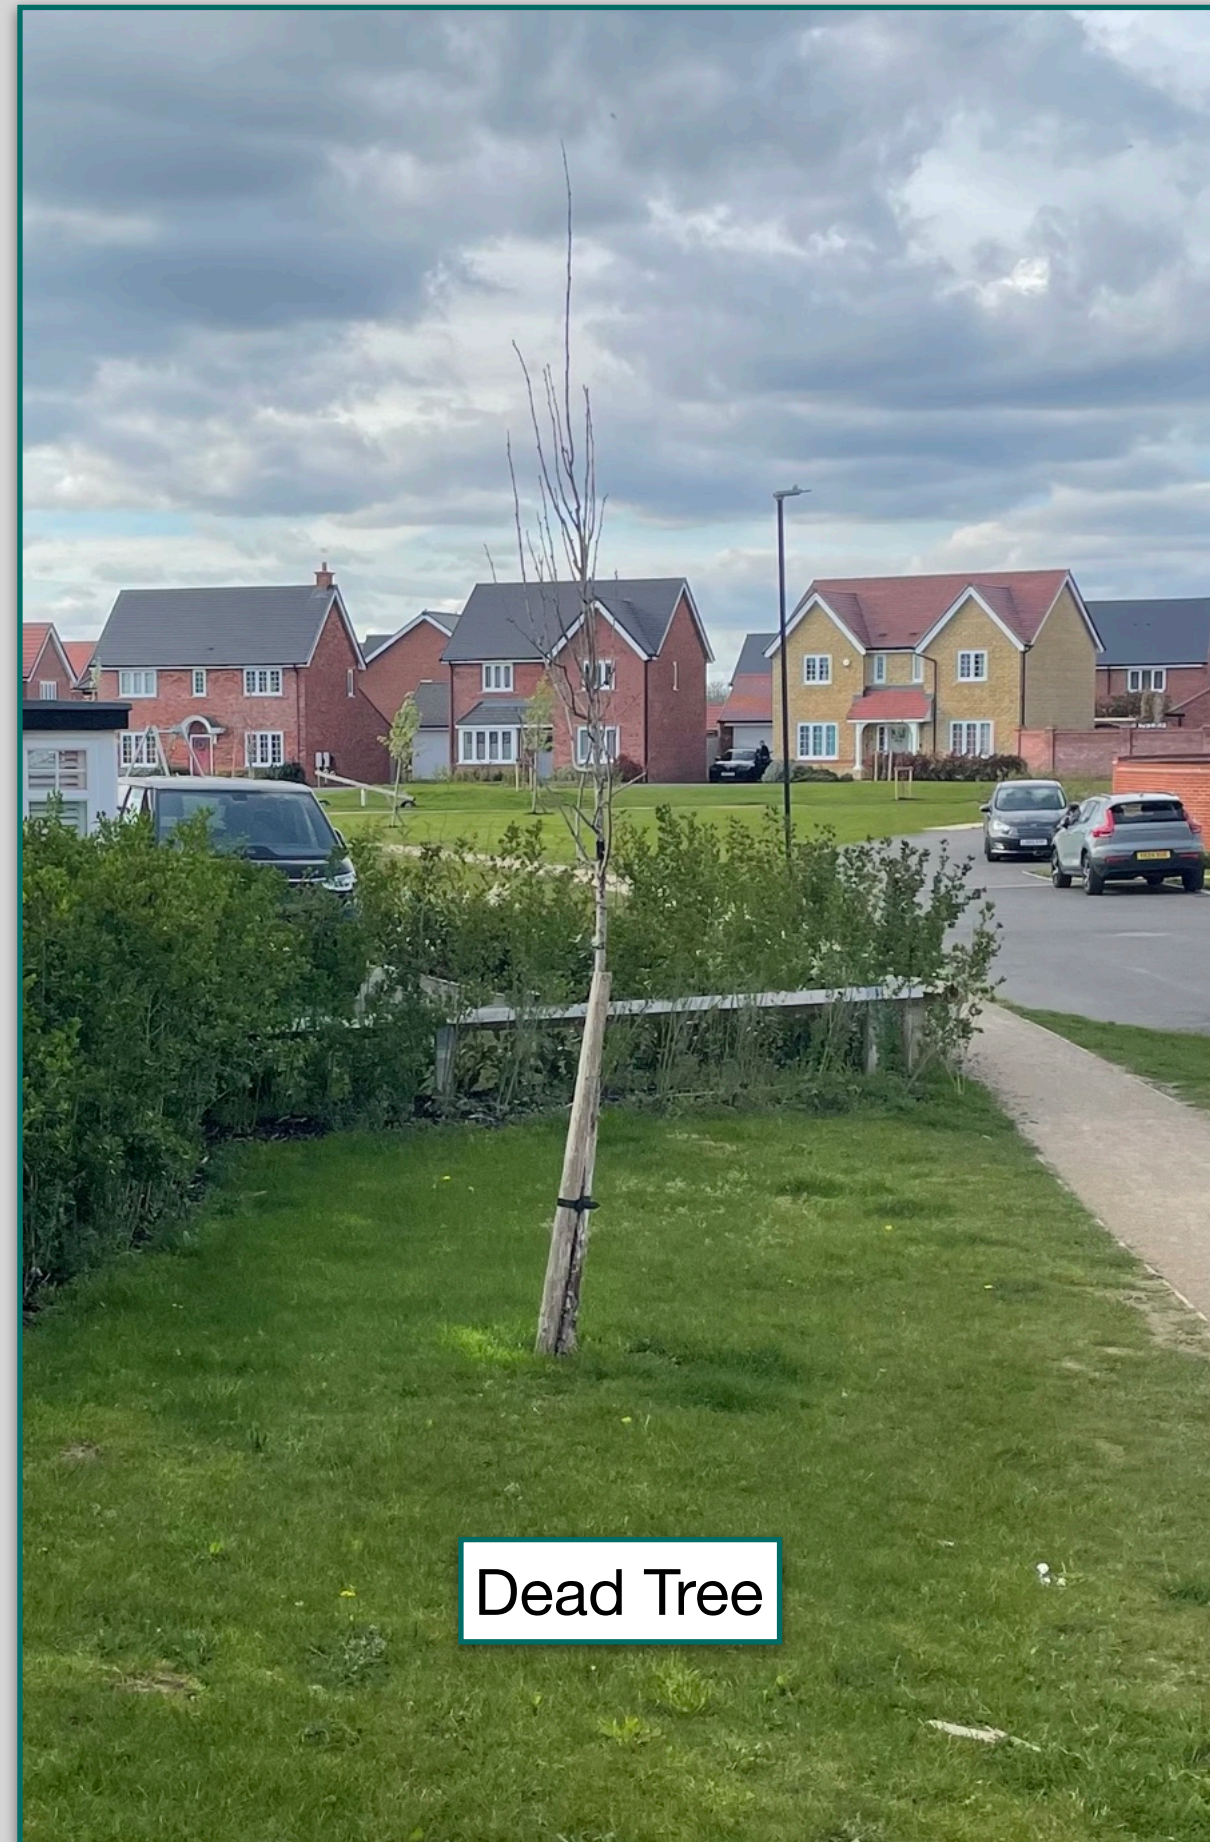
Ironbridge Road

Dead Tree

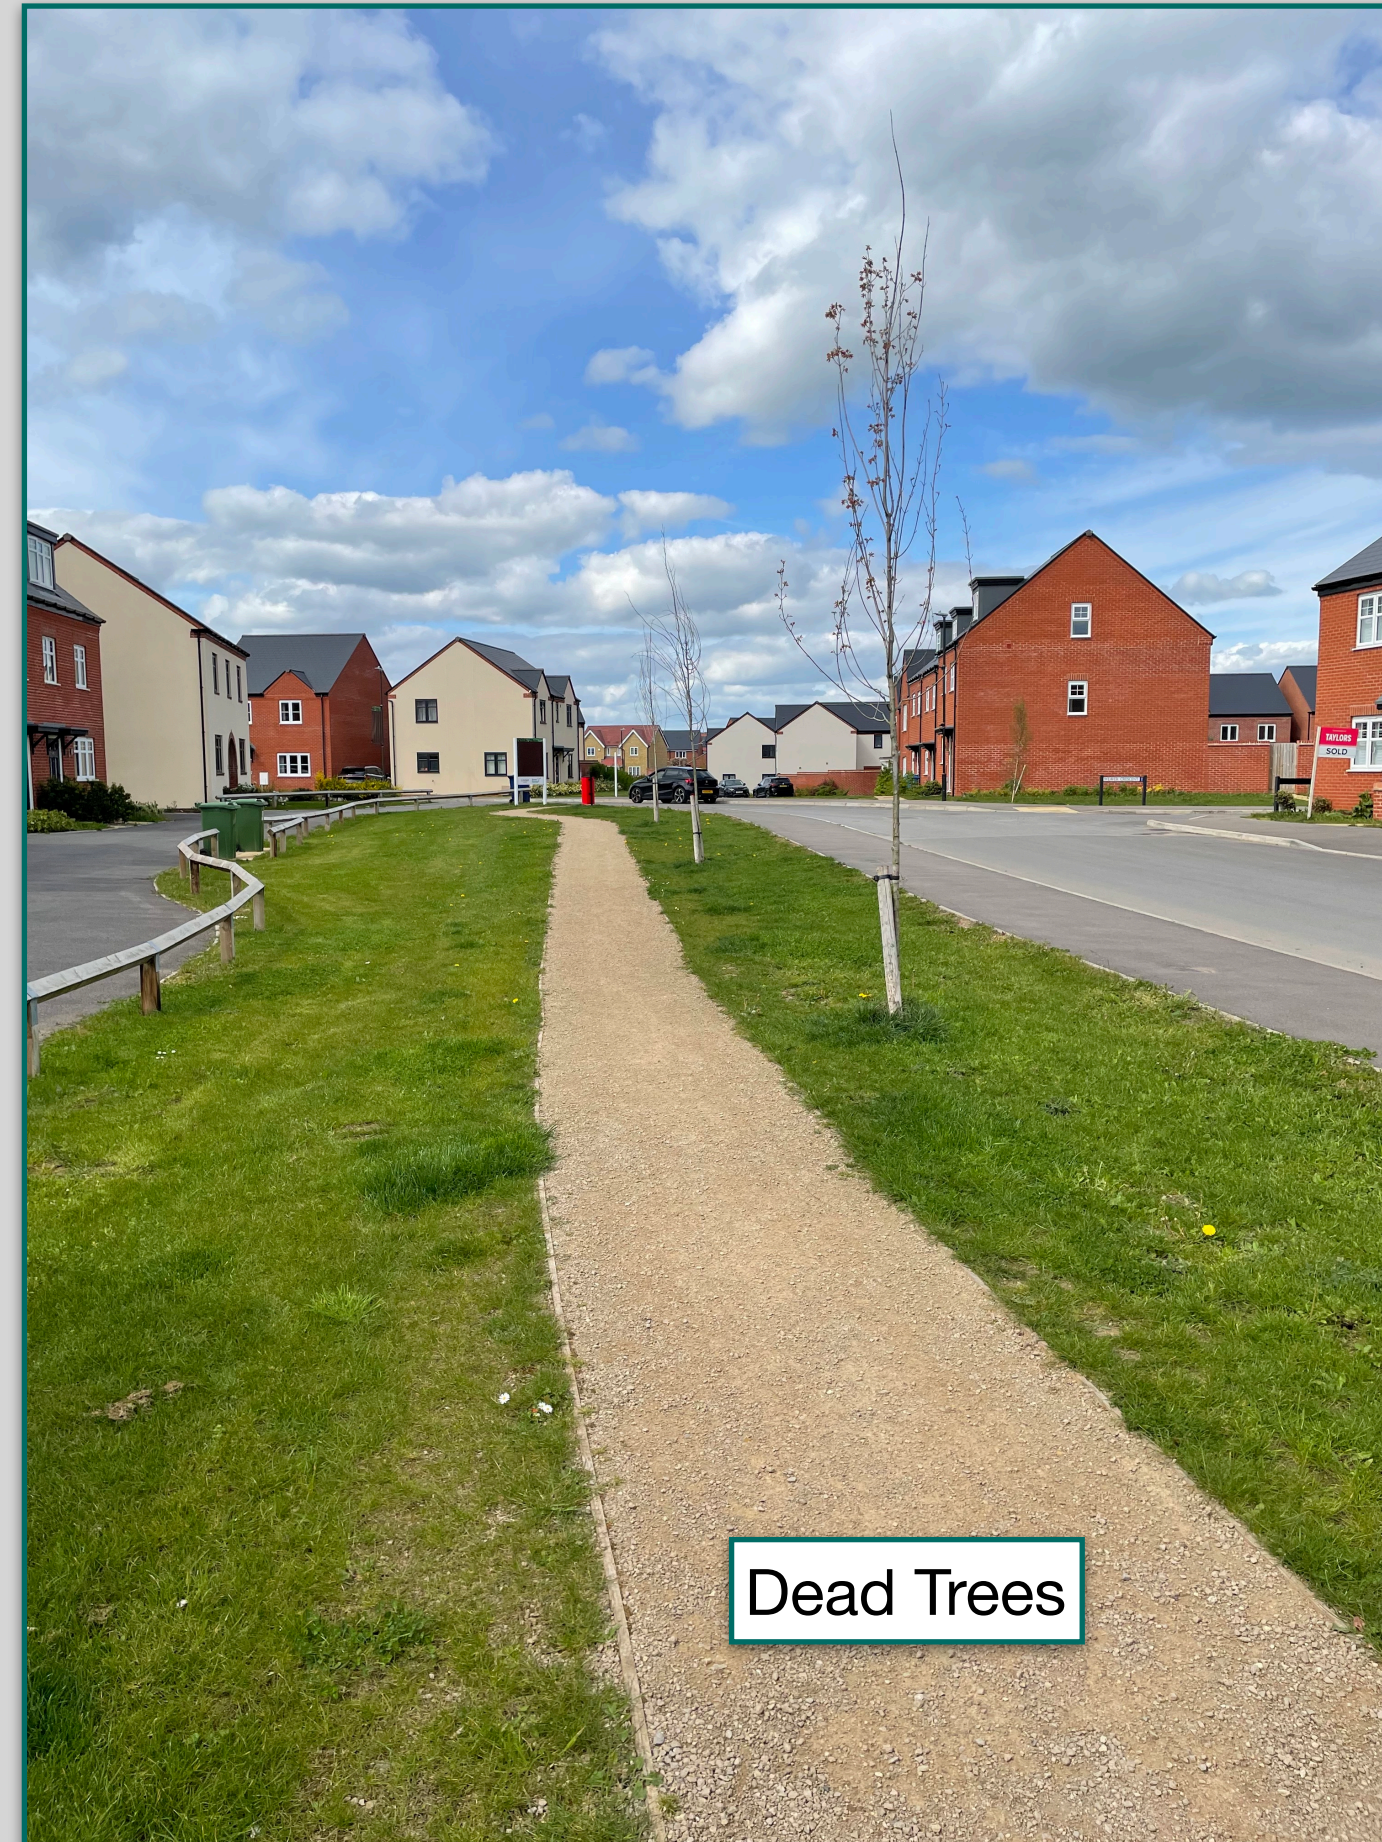
Dead Trees

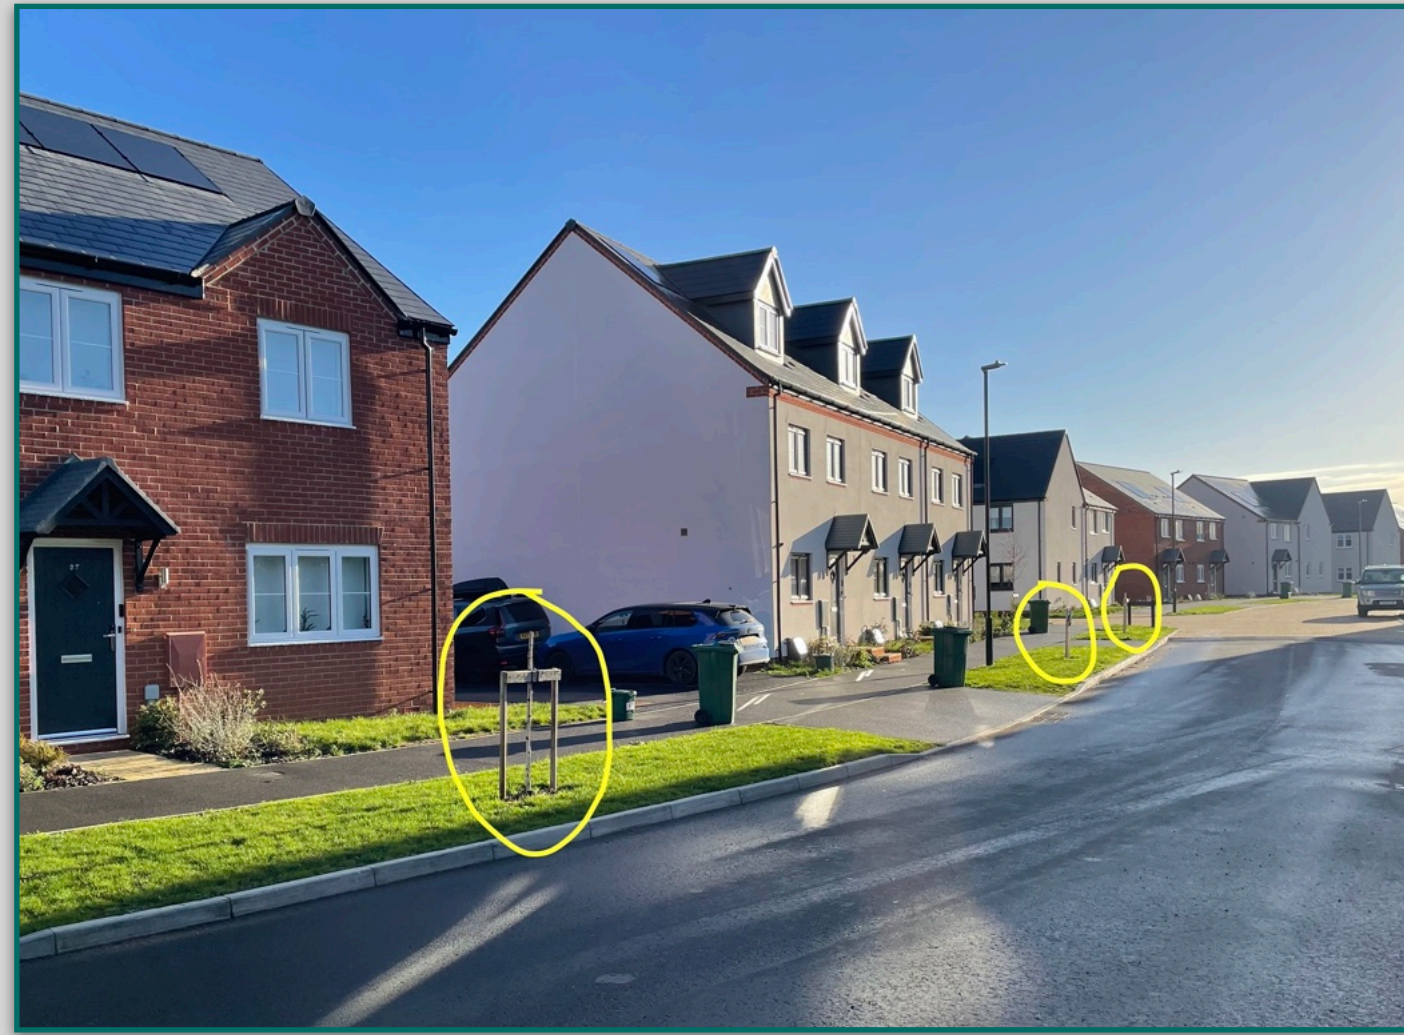
Apley Road

Broken Trees

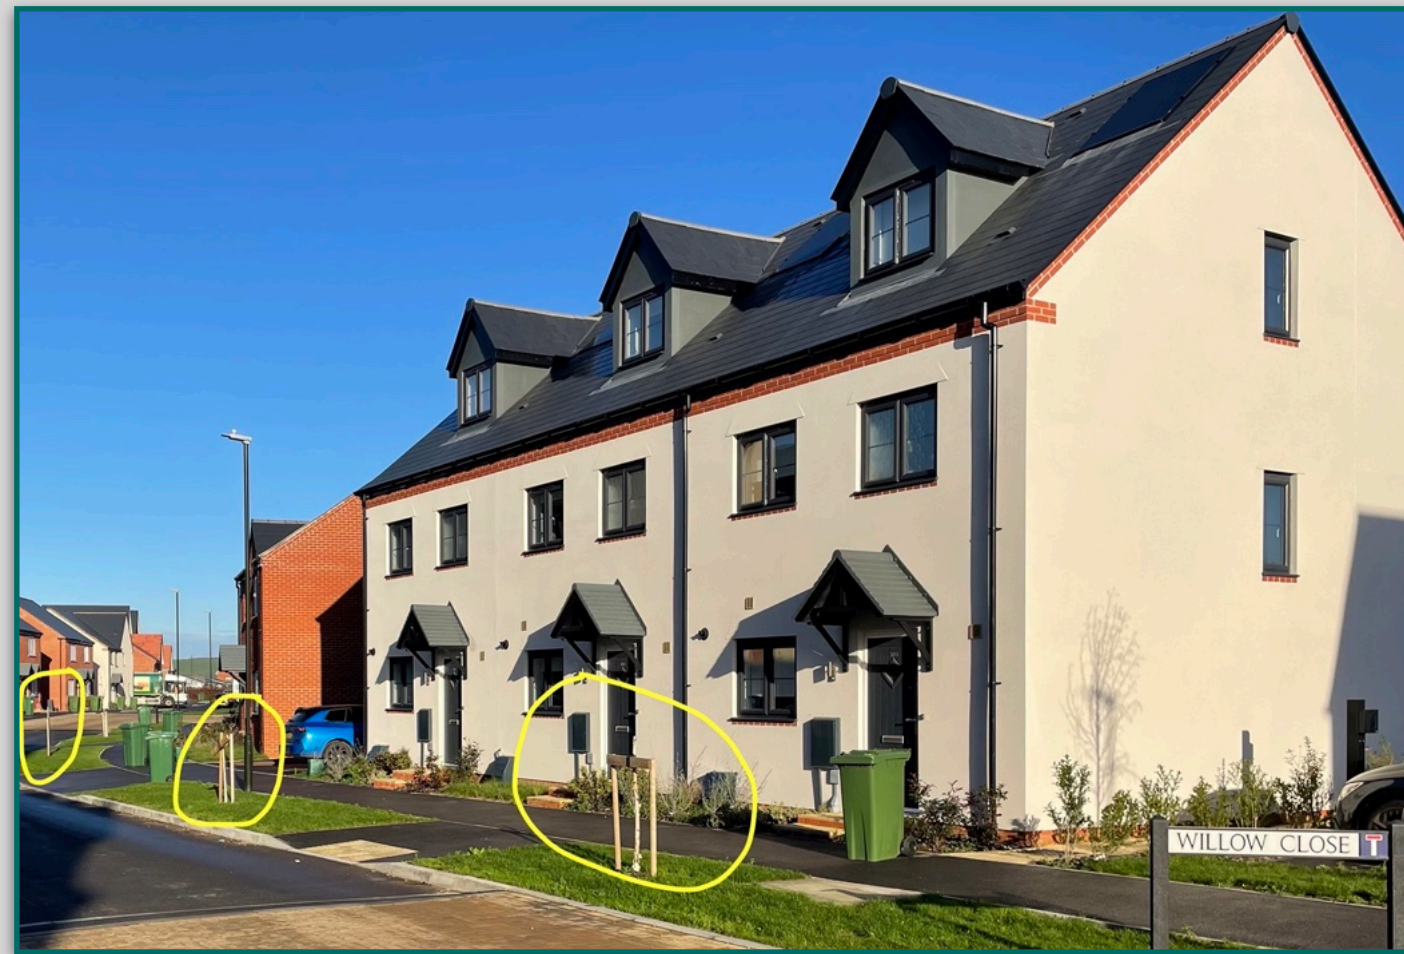
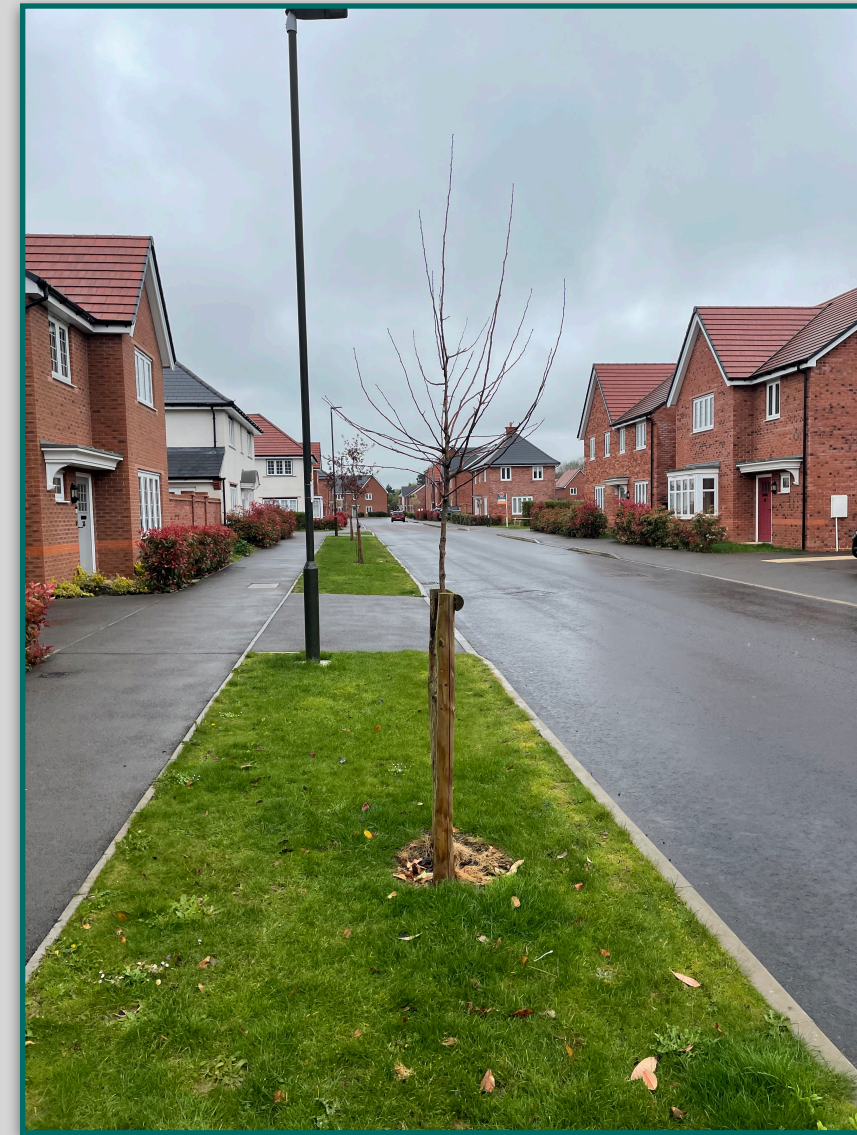
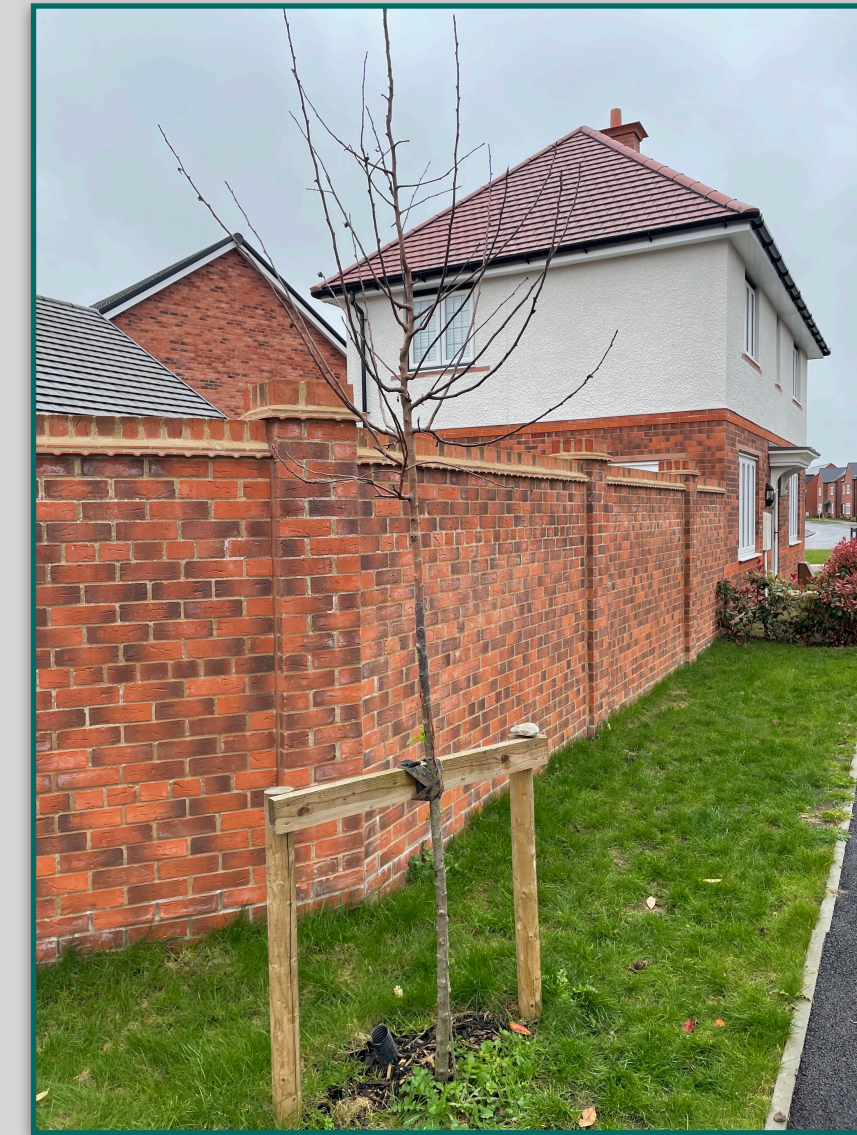
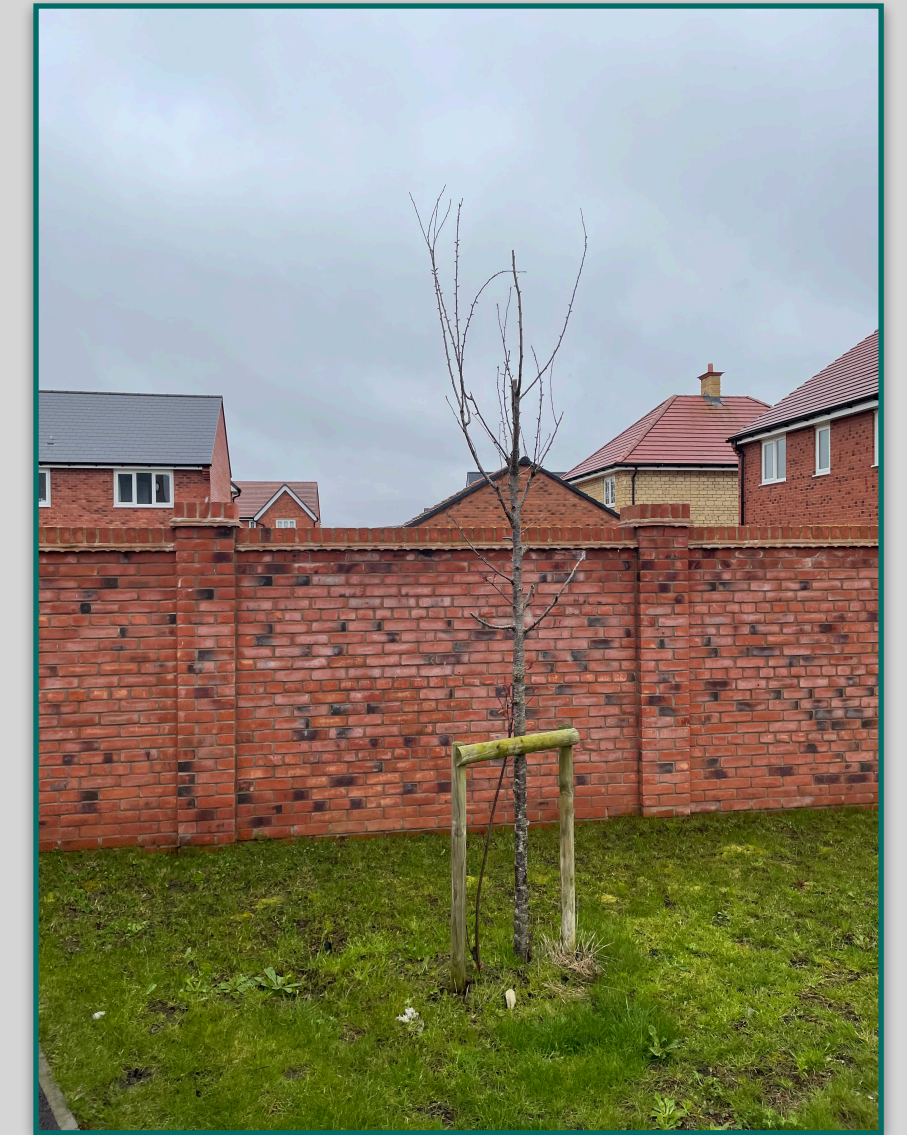
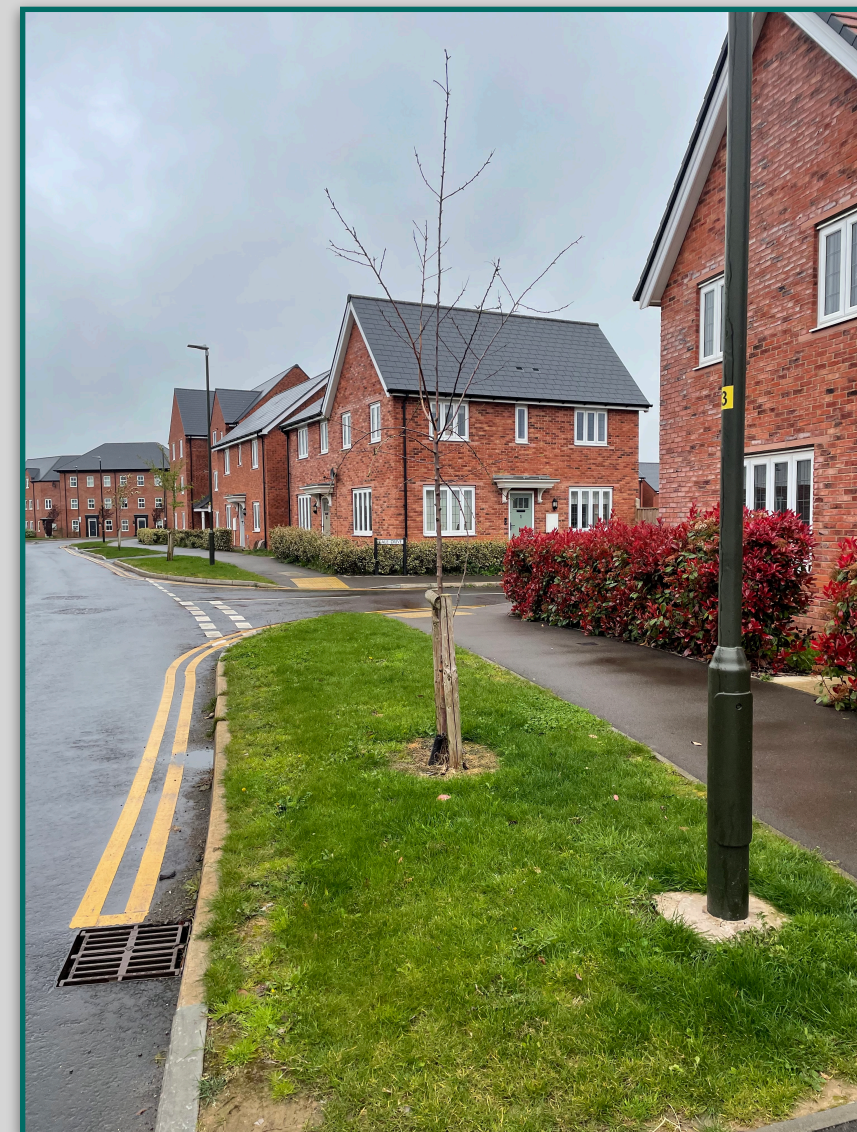
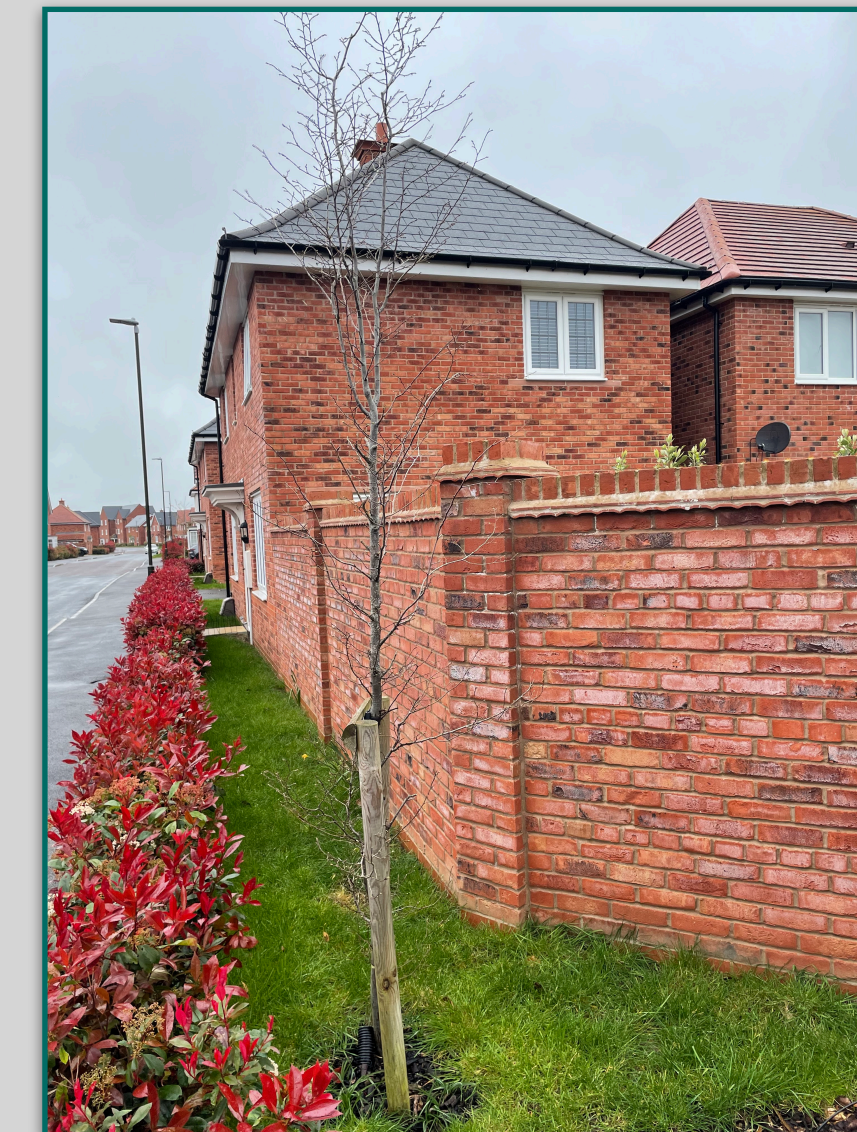
Dead Trees

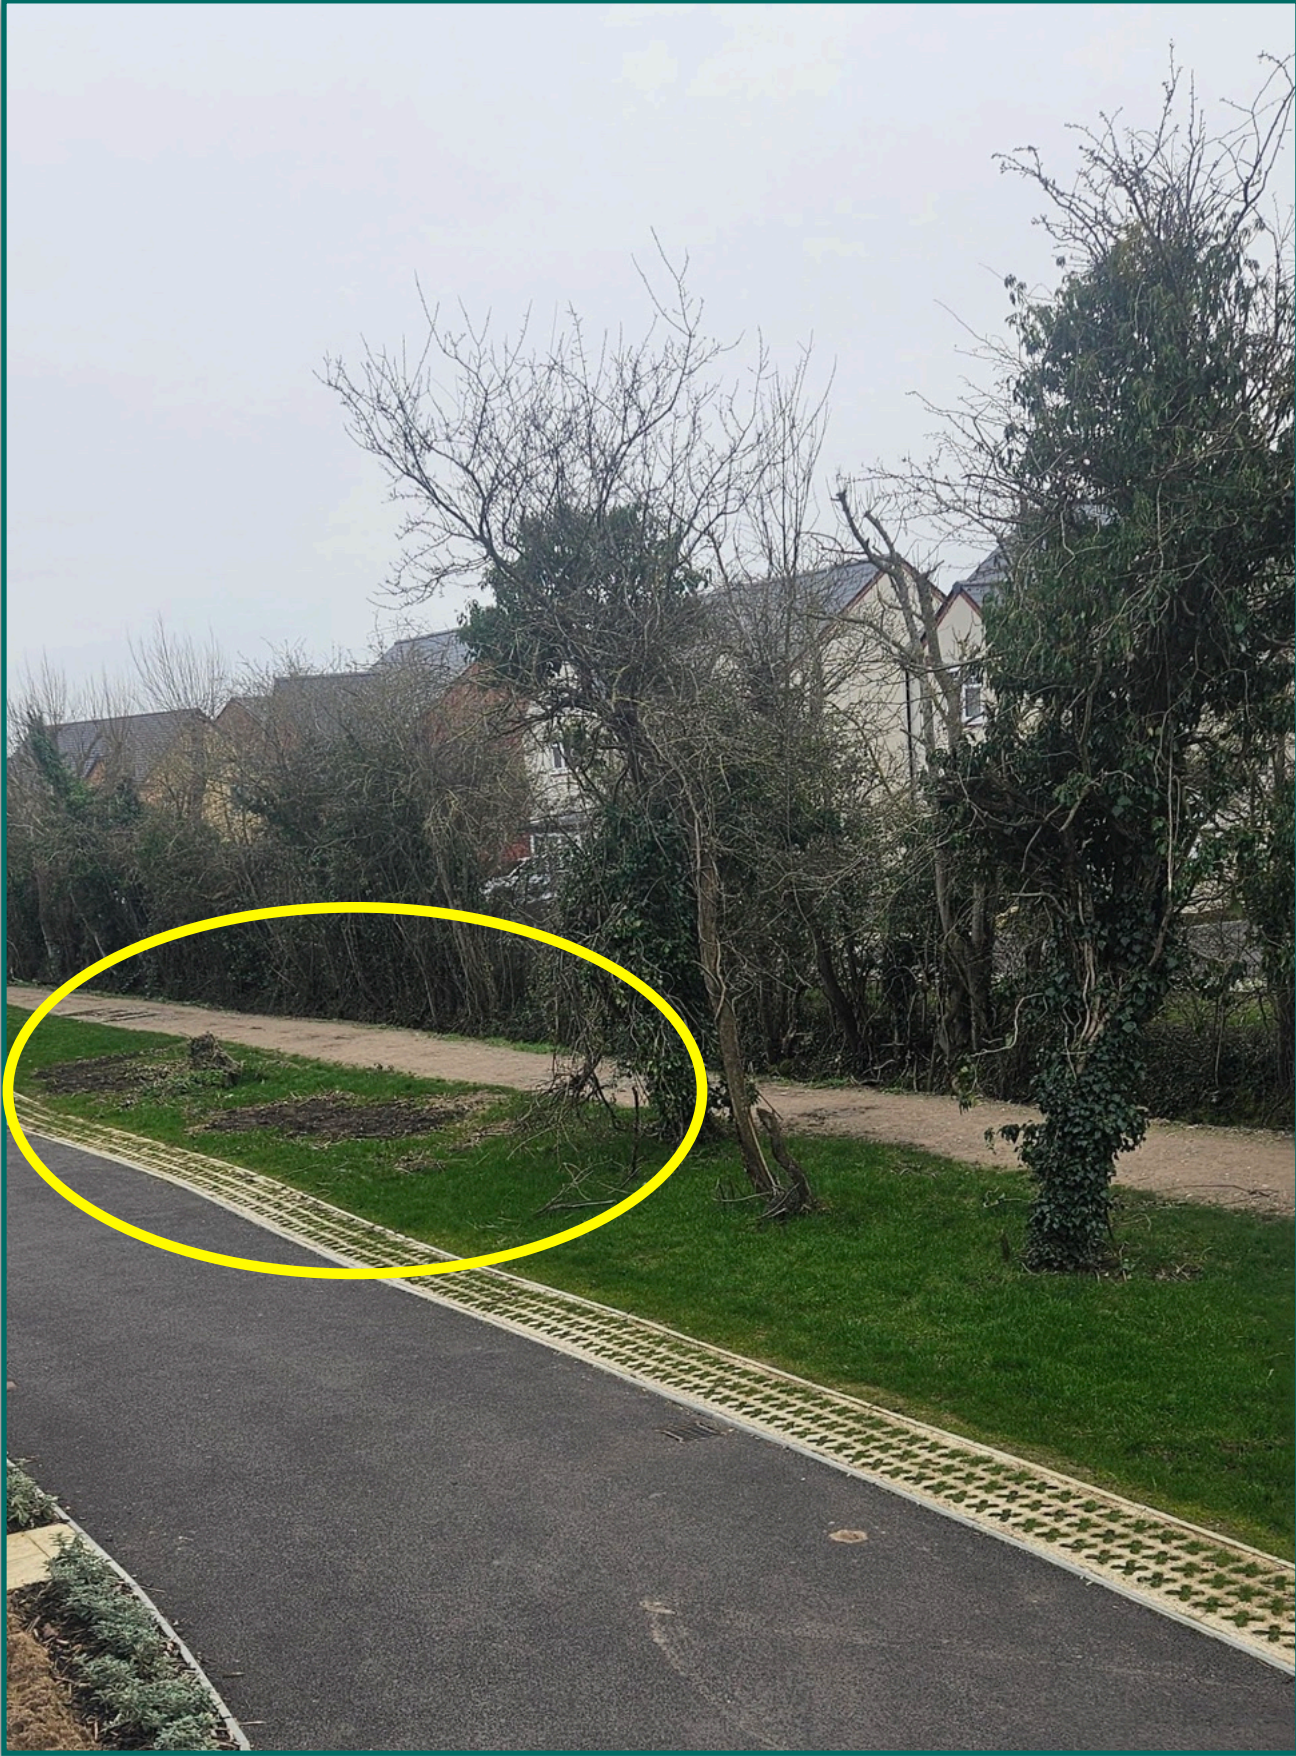
Elderberry Gardens - Bridle

Missing Trees

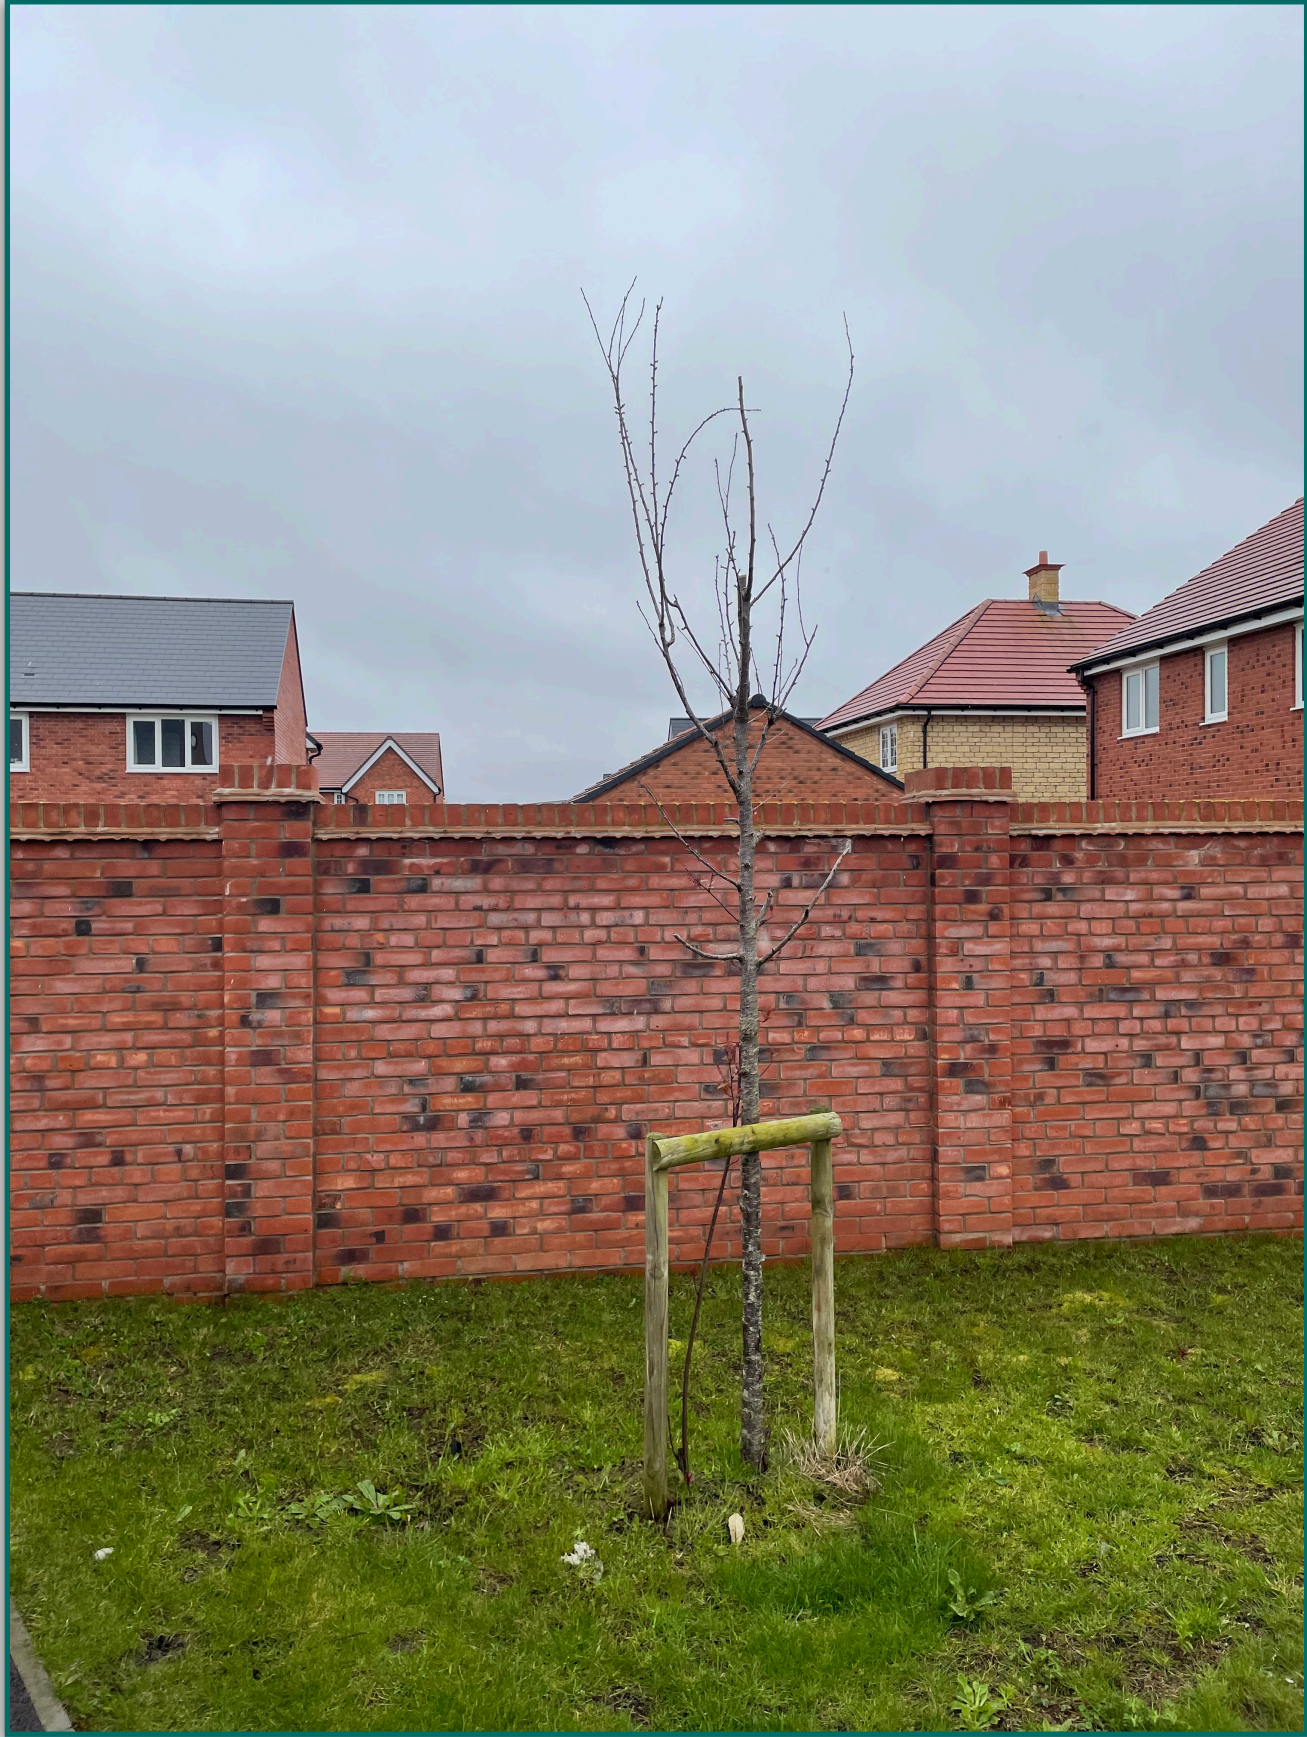
Sorrell Street

Dead Trees

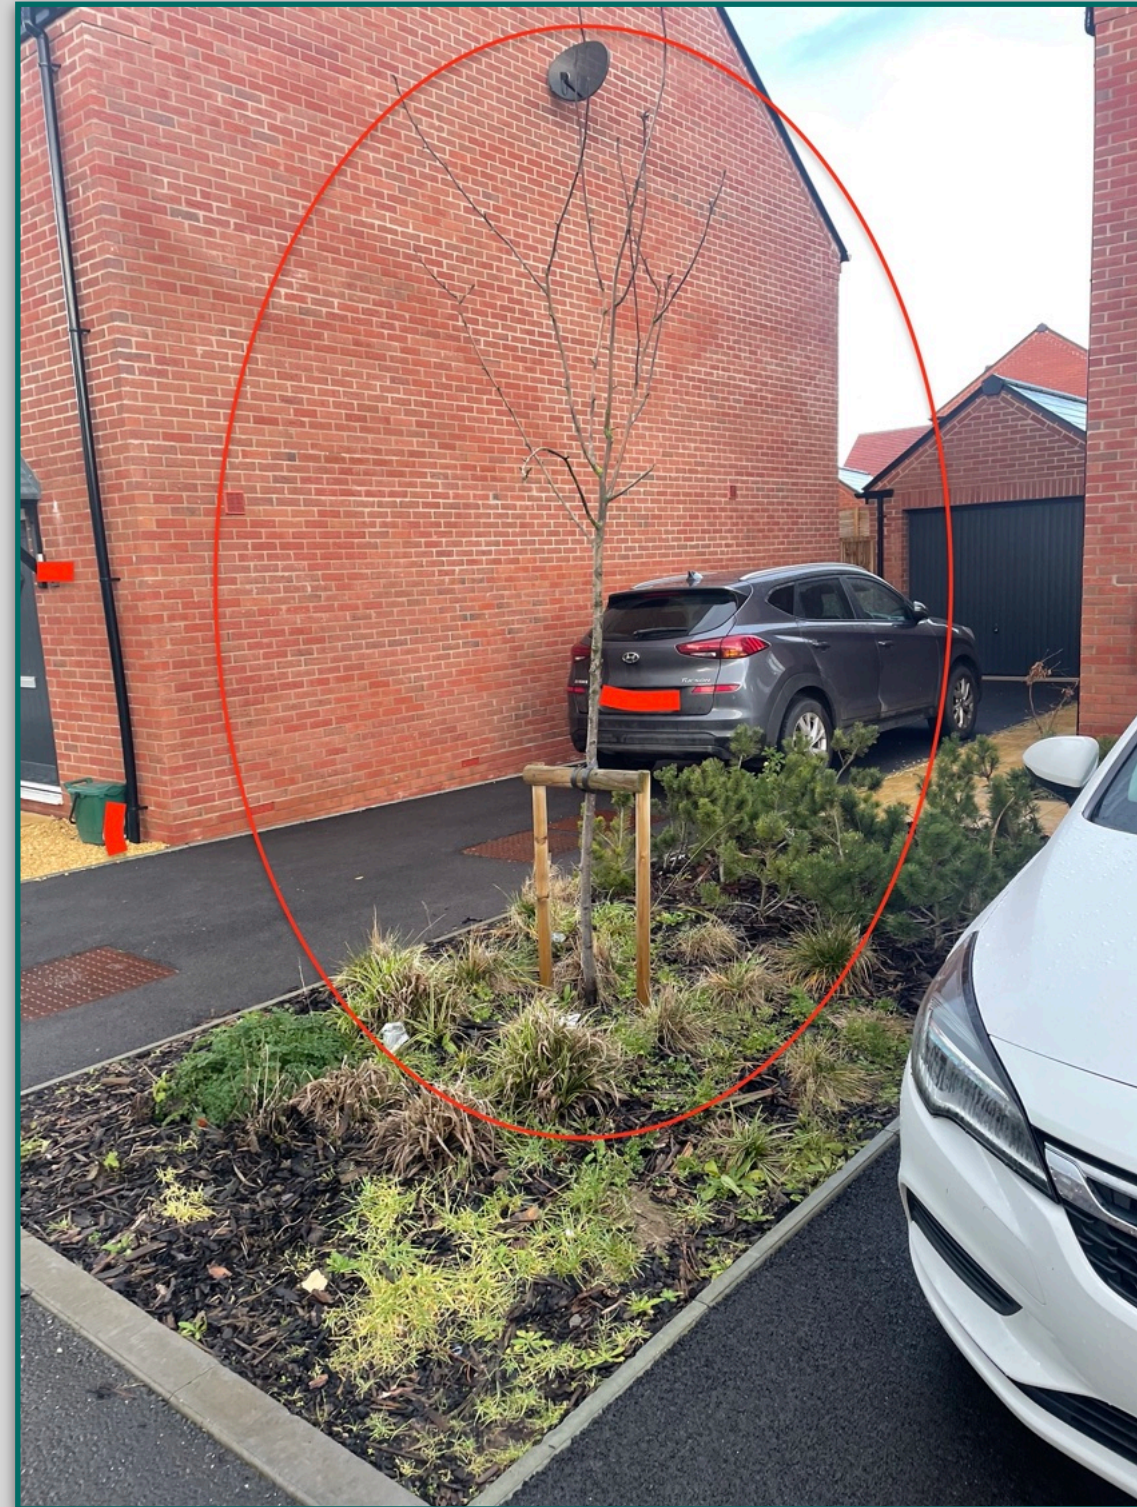
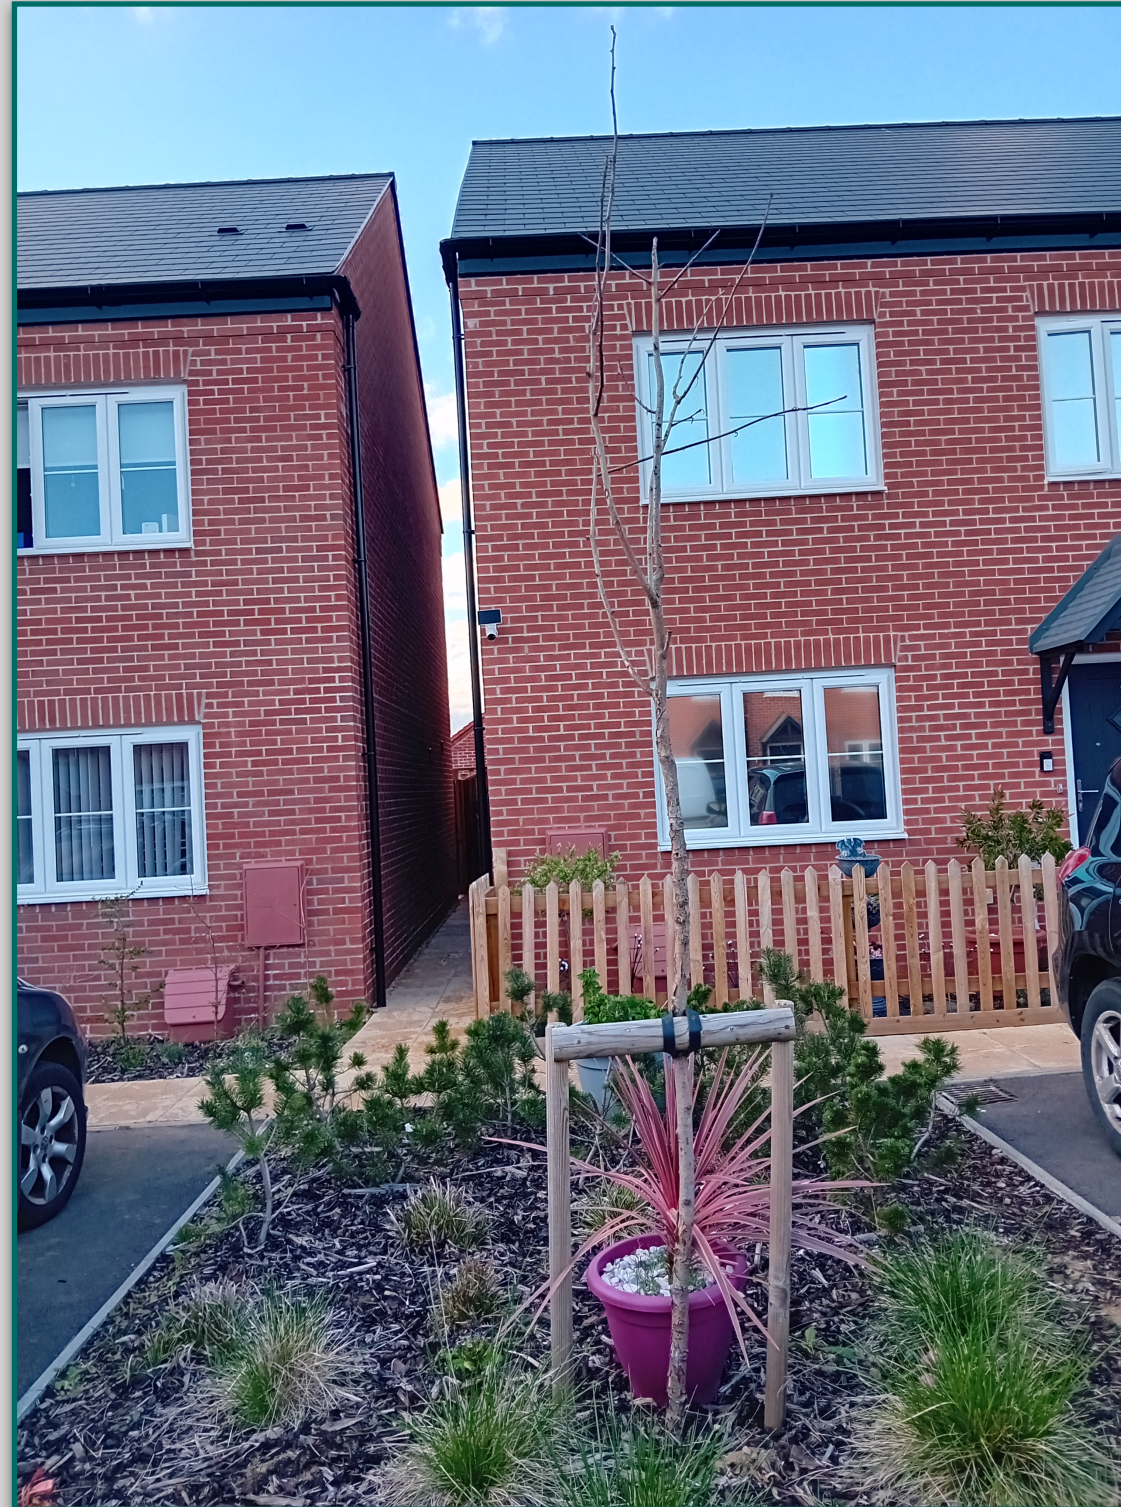
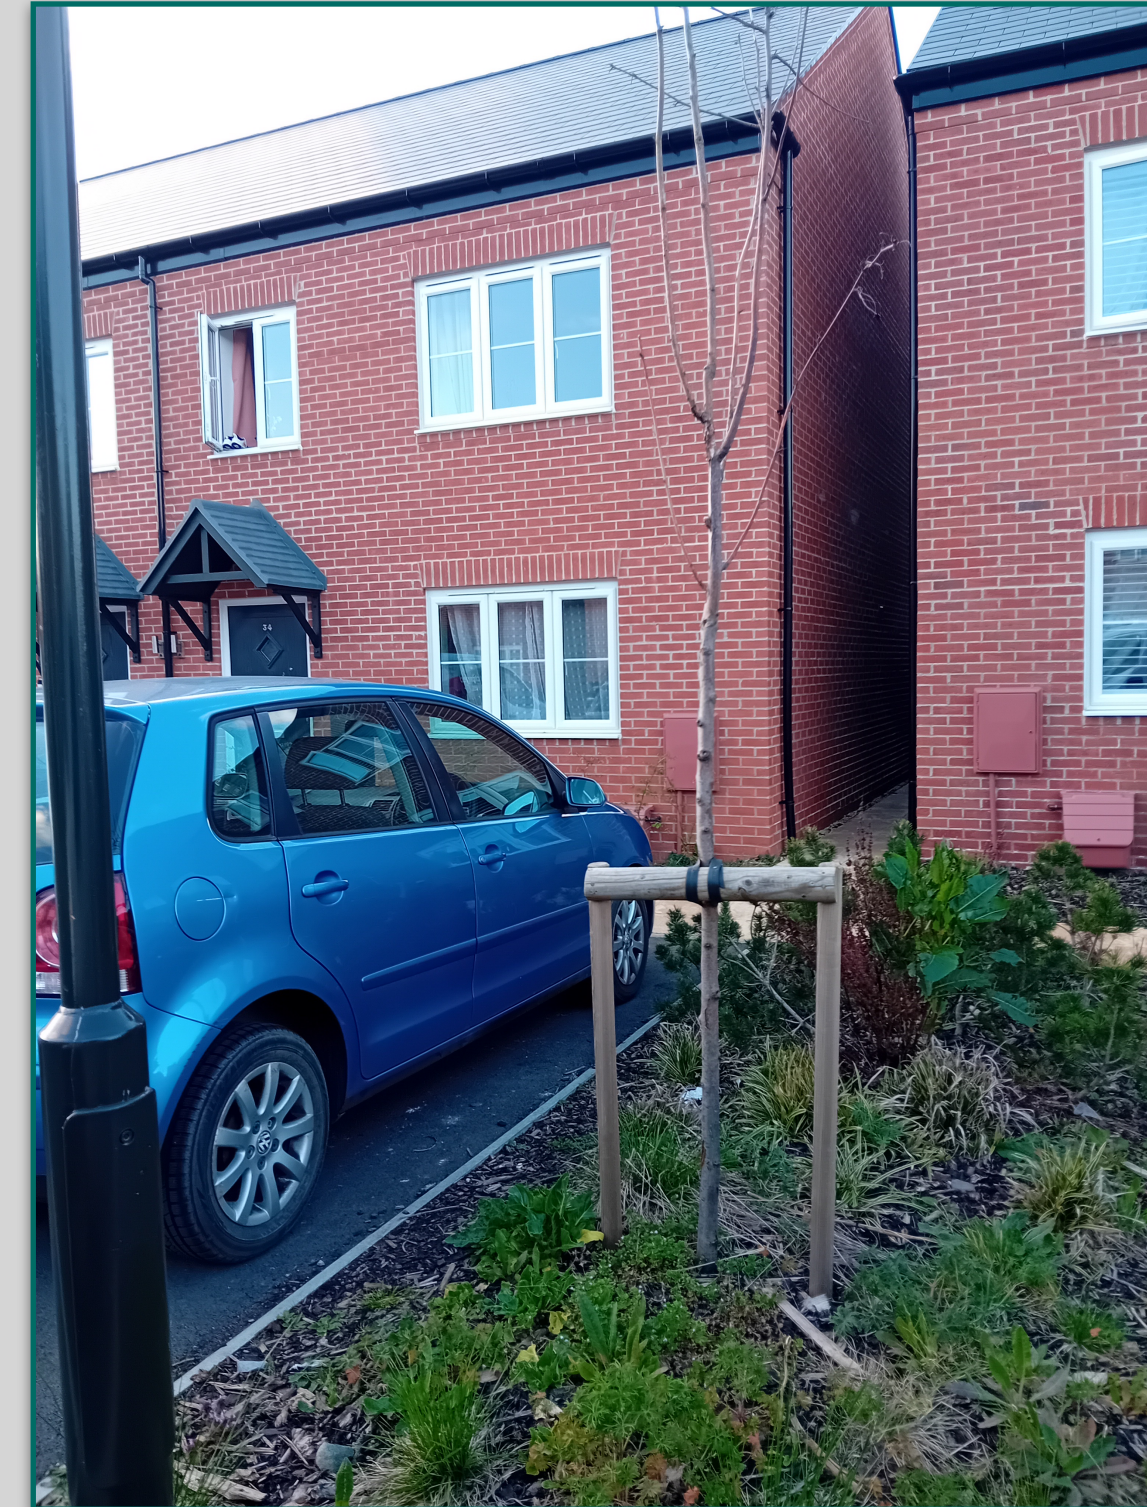
Weaver Crescent

Dead Trees x 6
