Twigworth Green

Follow-Up Report of Dead or Damaged Saplings & General Landscaping

22 April 2026

Cllr John Redfern - Twigworth Parish Council

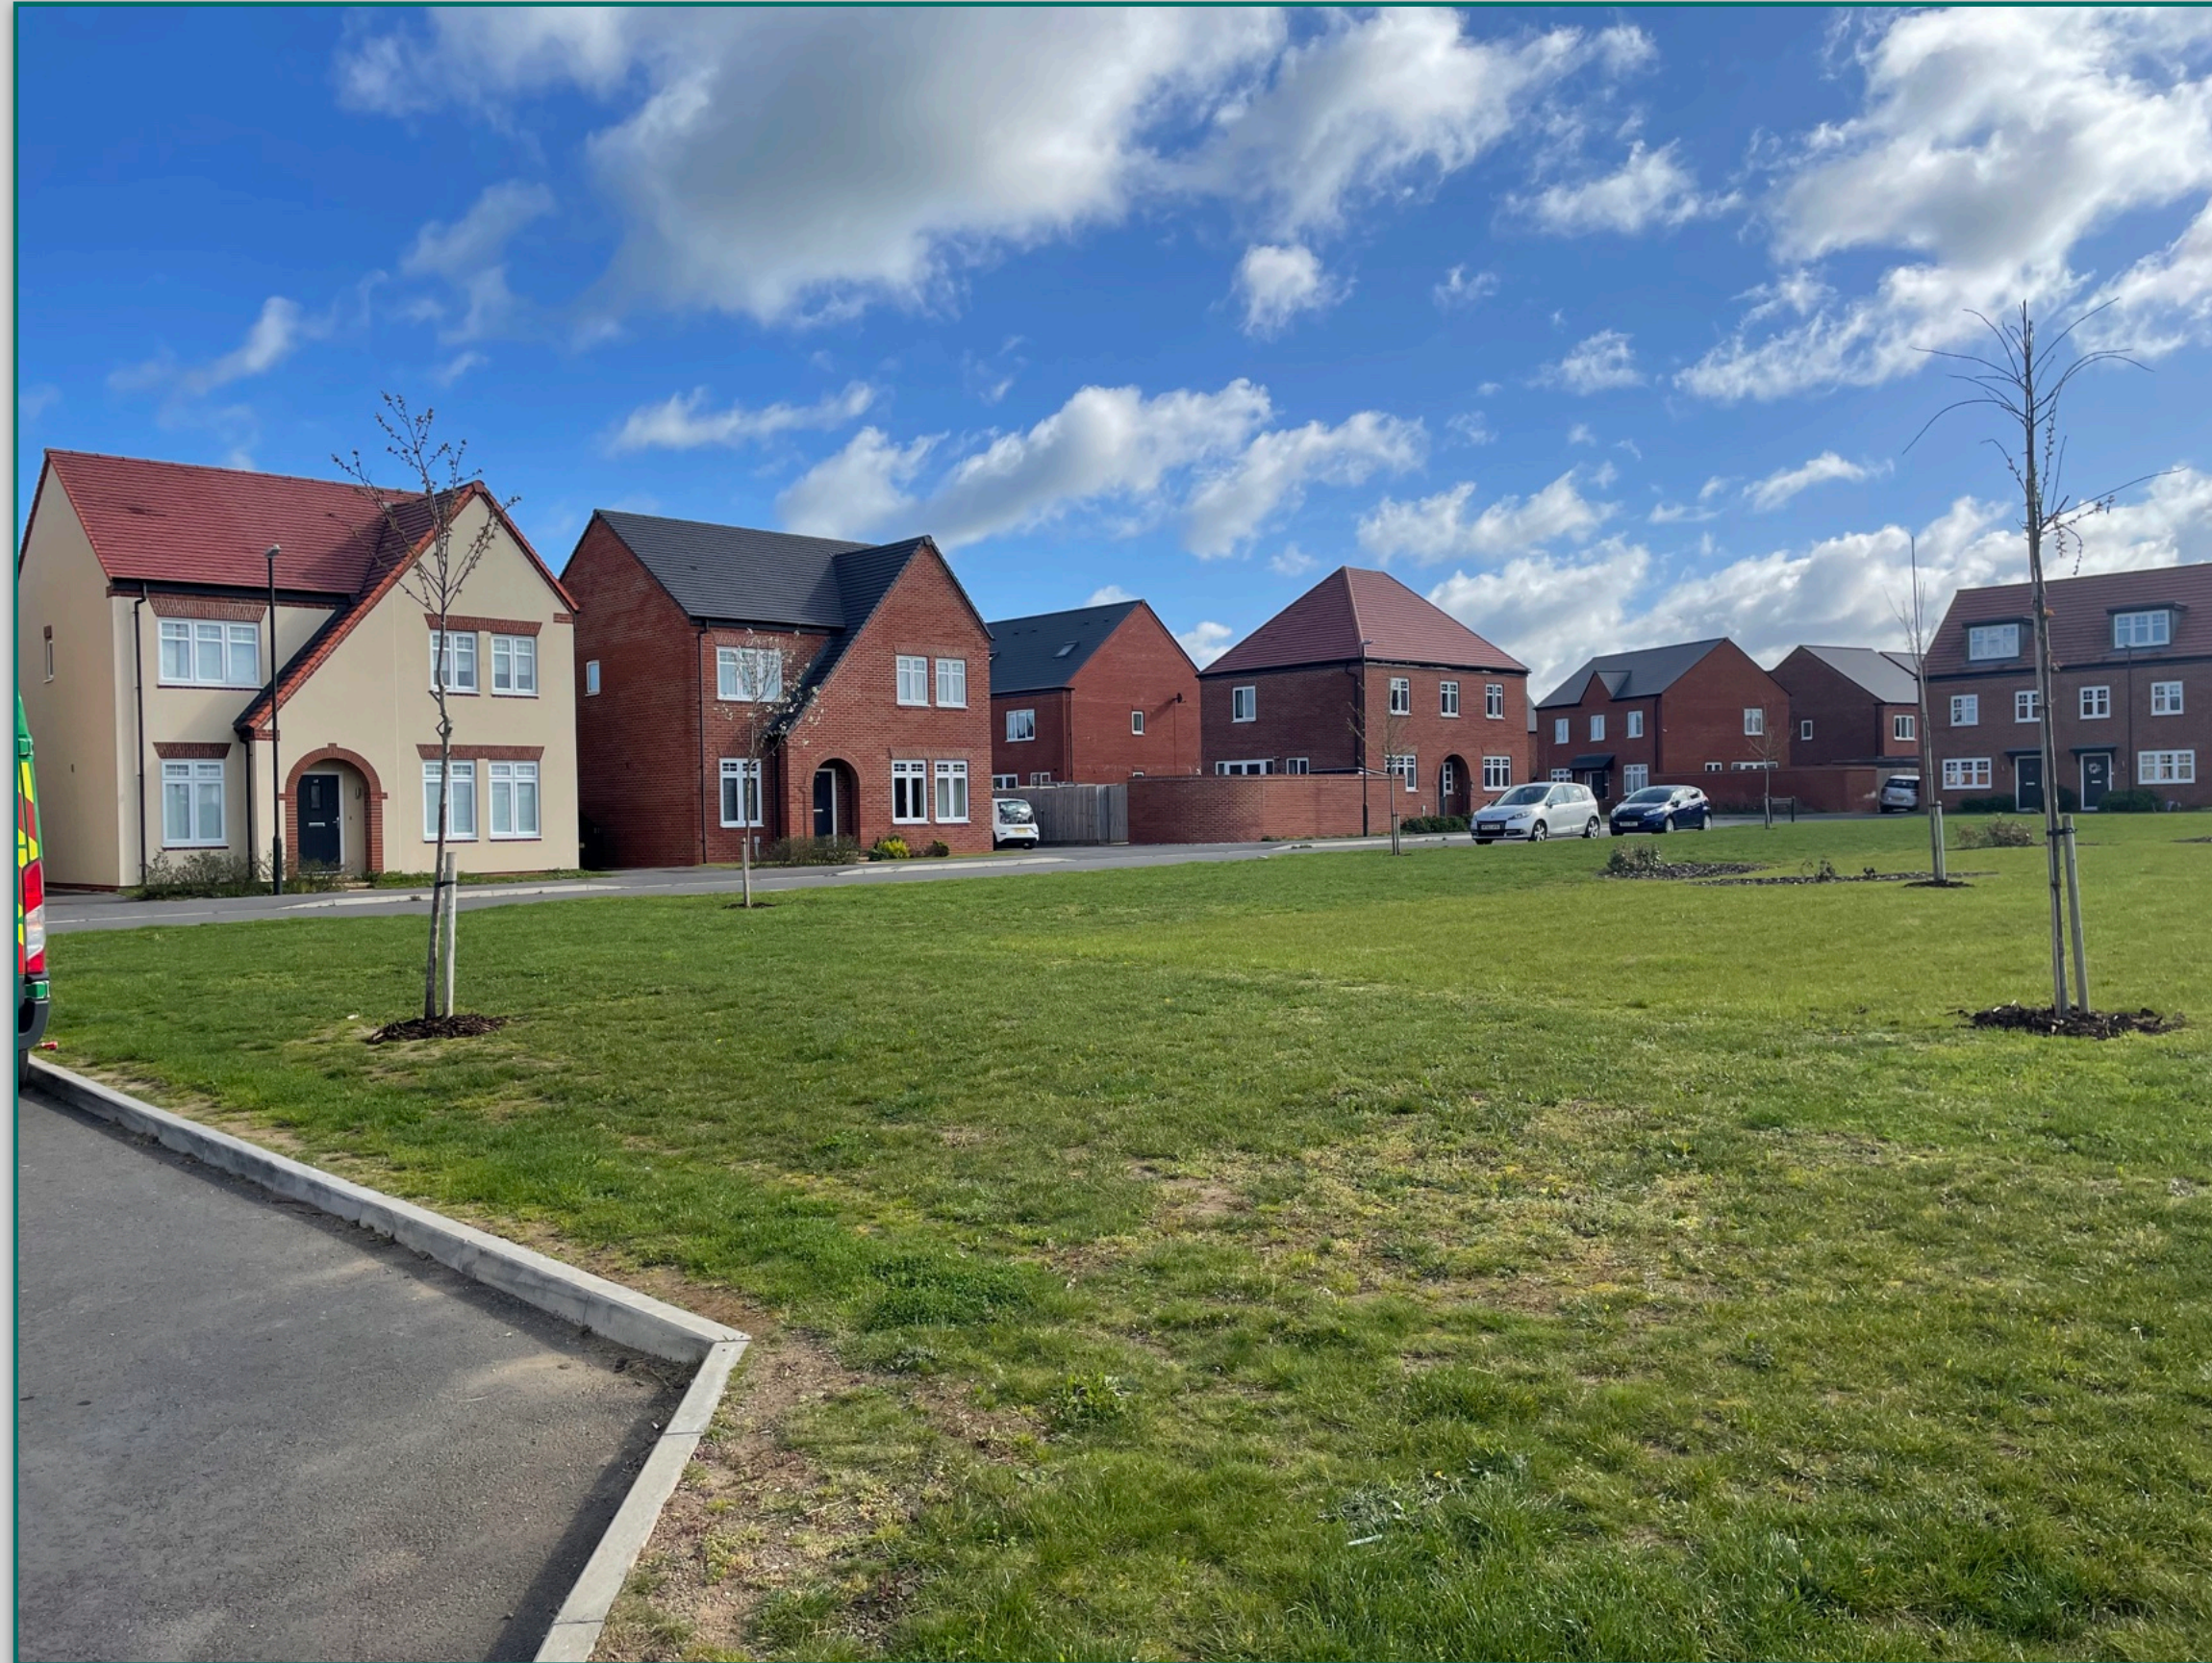
Comfrey Gardens

The trees do not look to be healthy and should be inspected

The shrub areas also look to be in a poor state and should be inspected

The grass areas are patchy due to poor seeding

There were parts of this land that were never seeded and just left

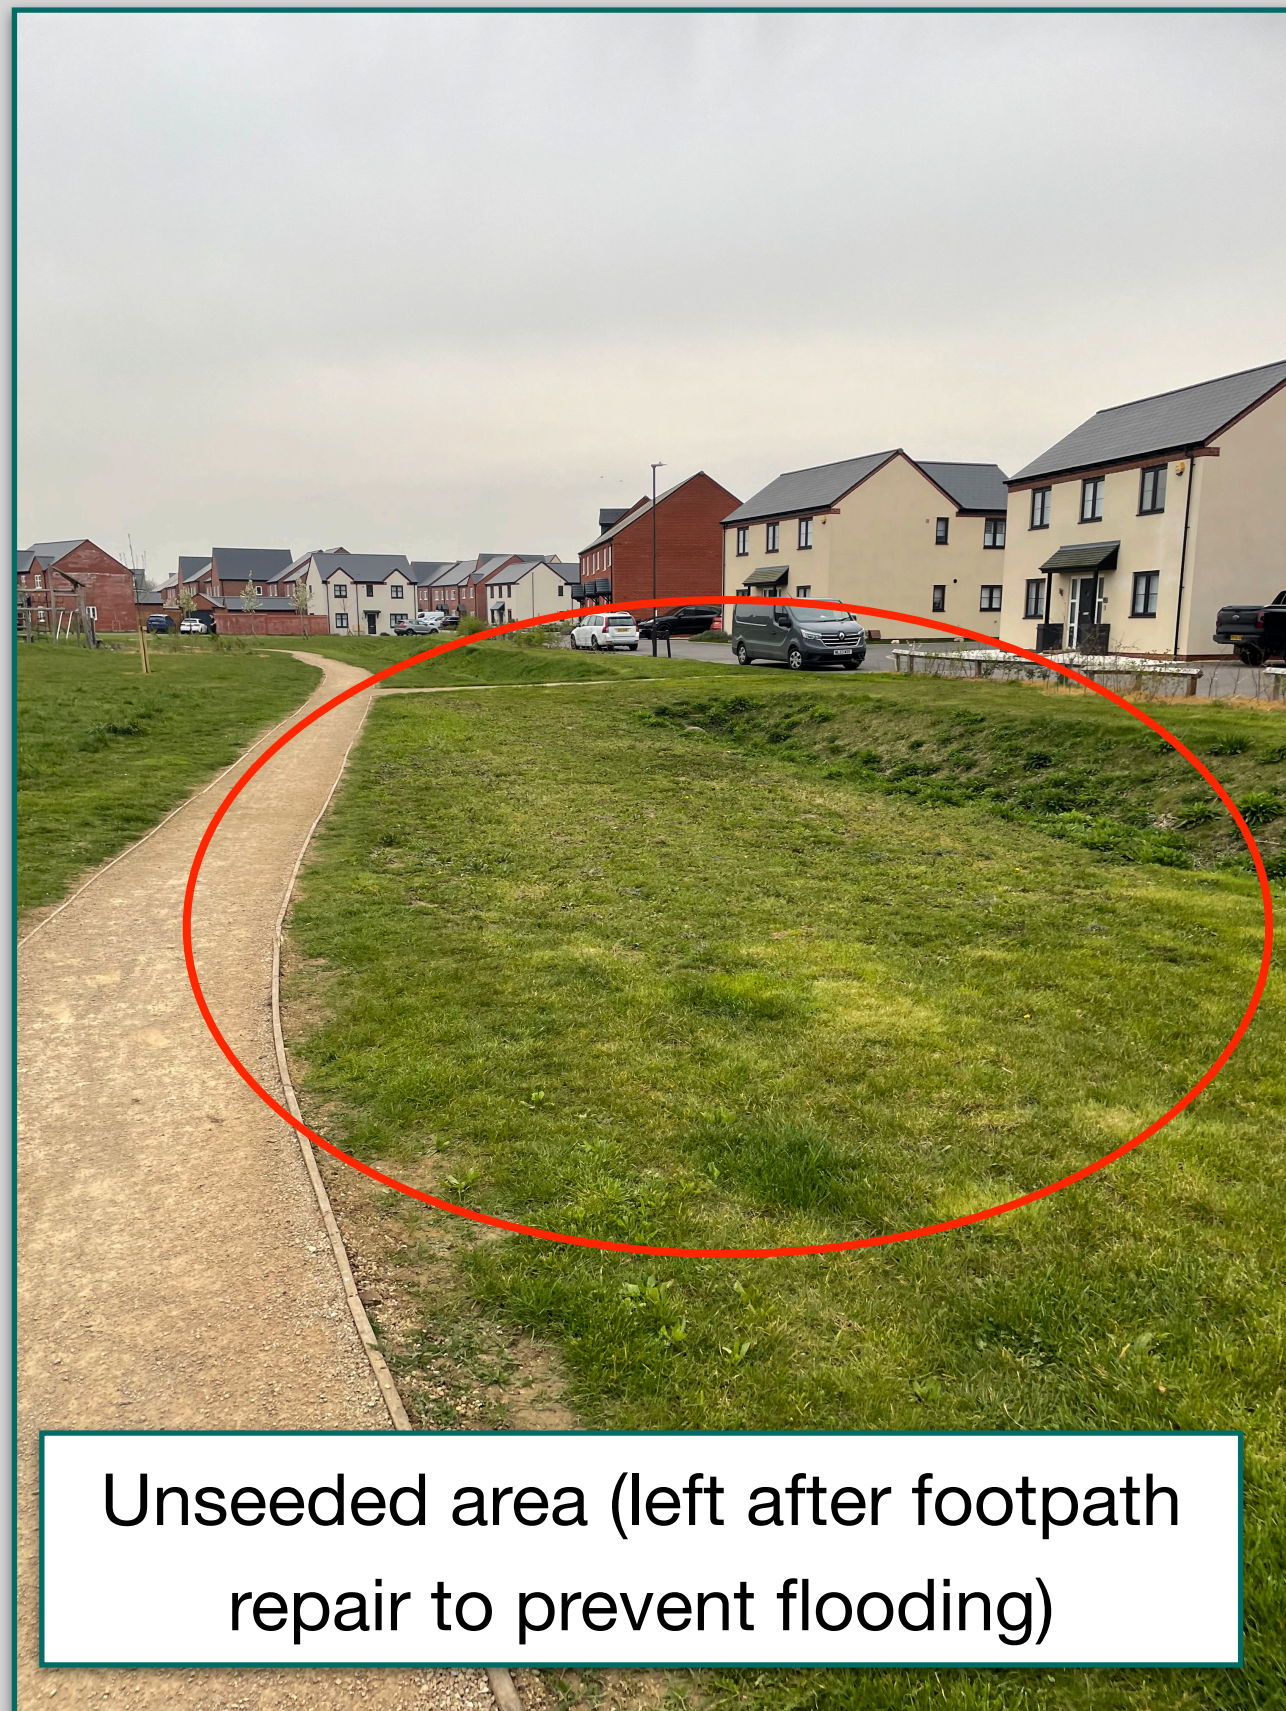
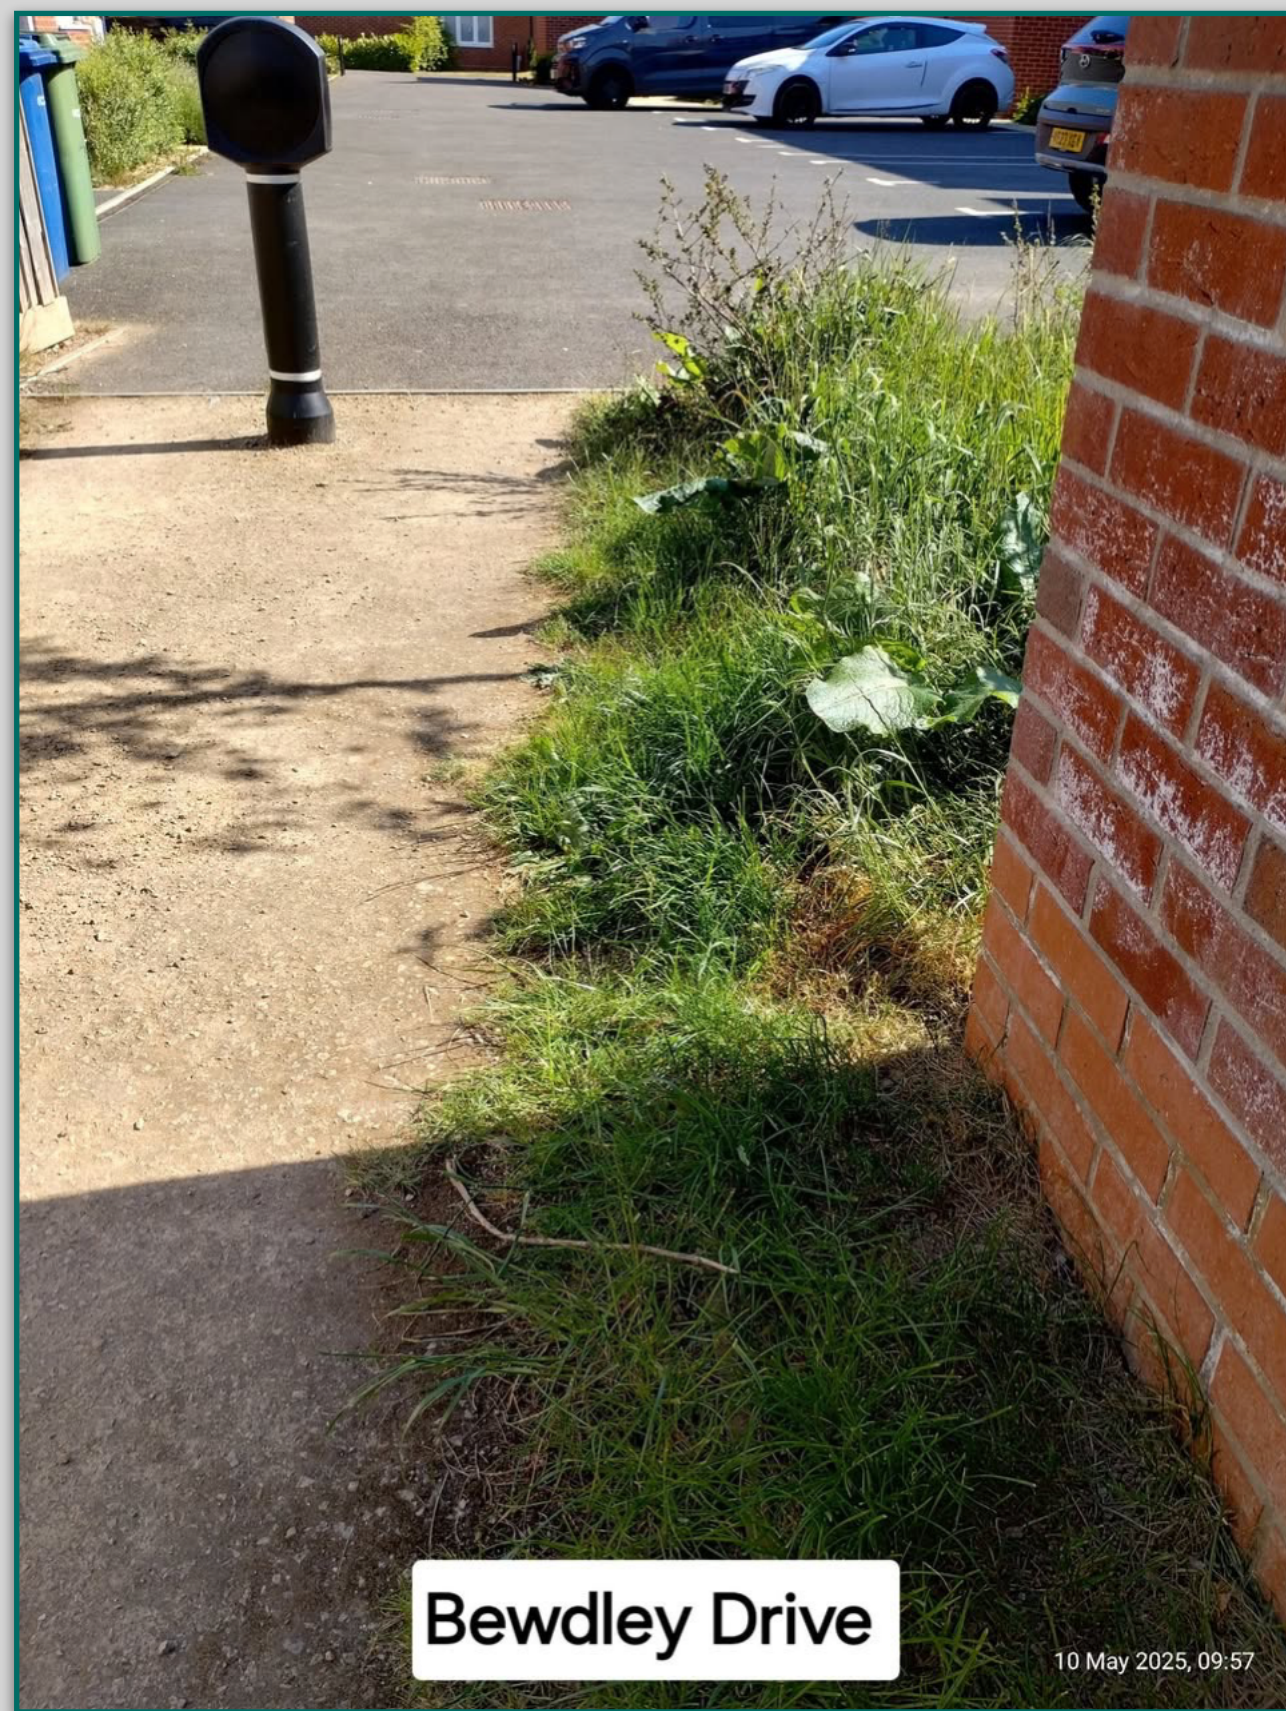
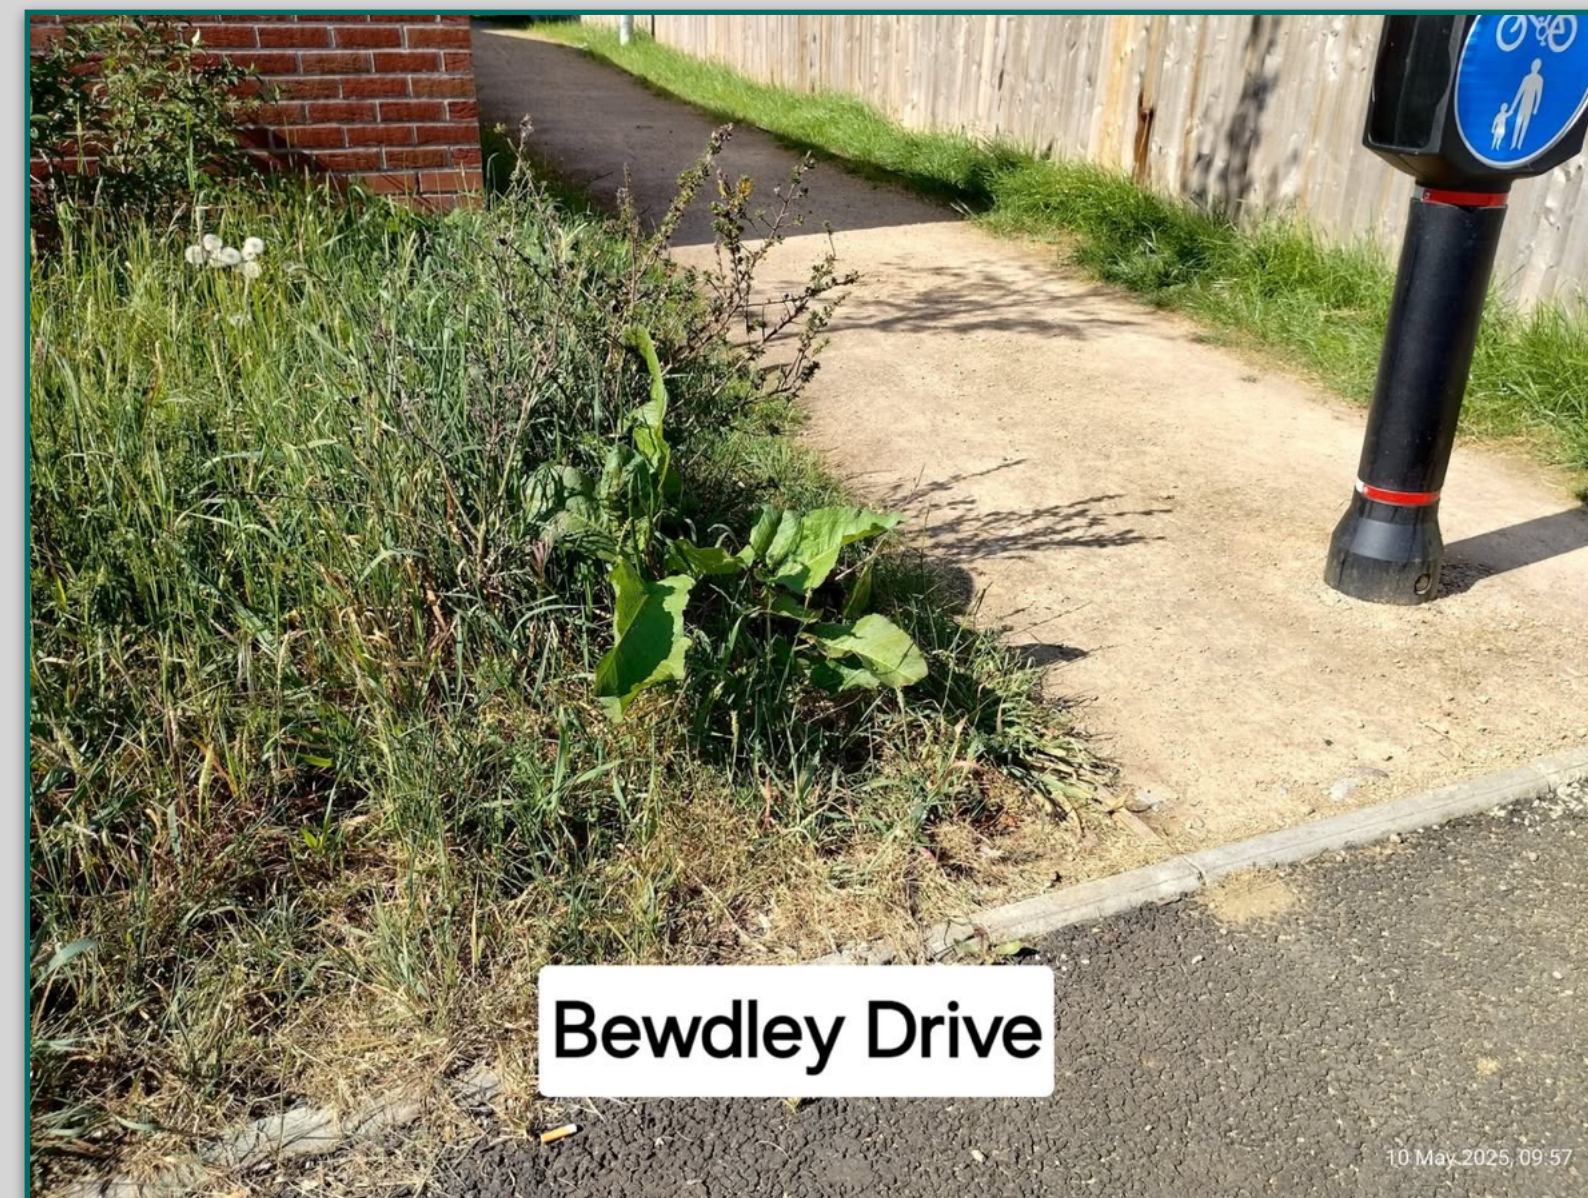
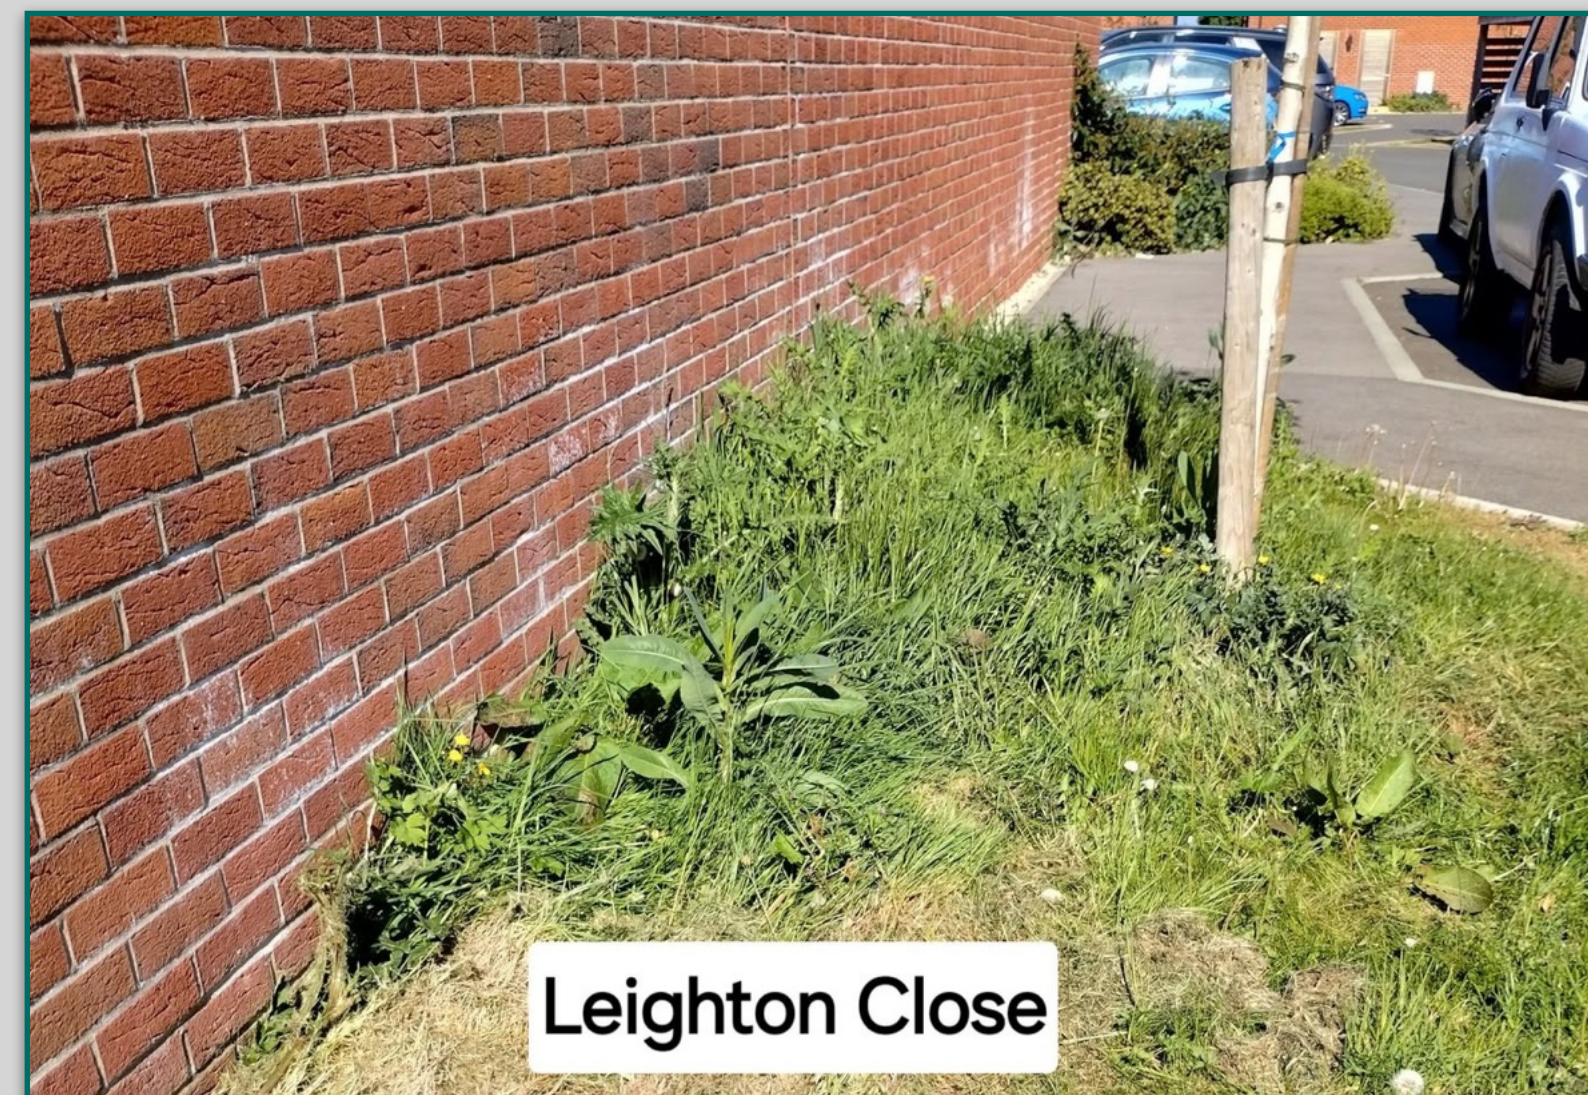
Poor Maintenance

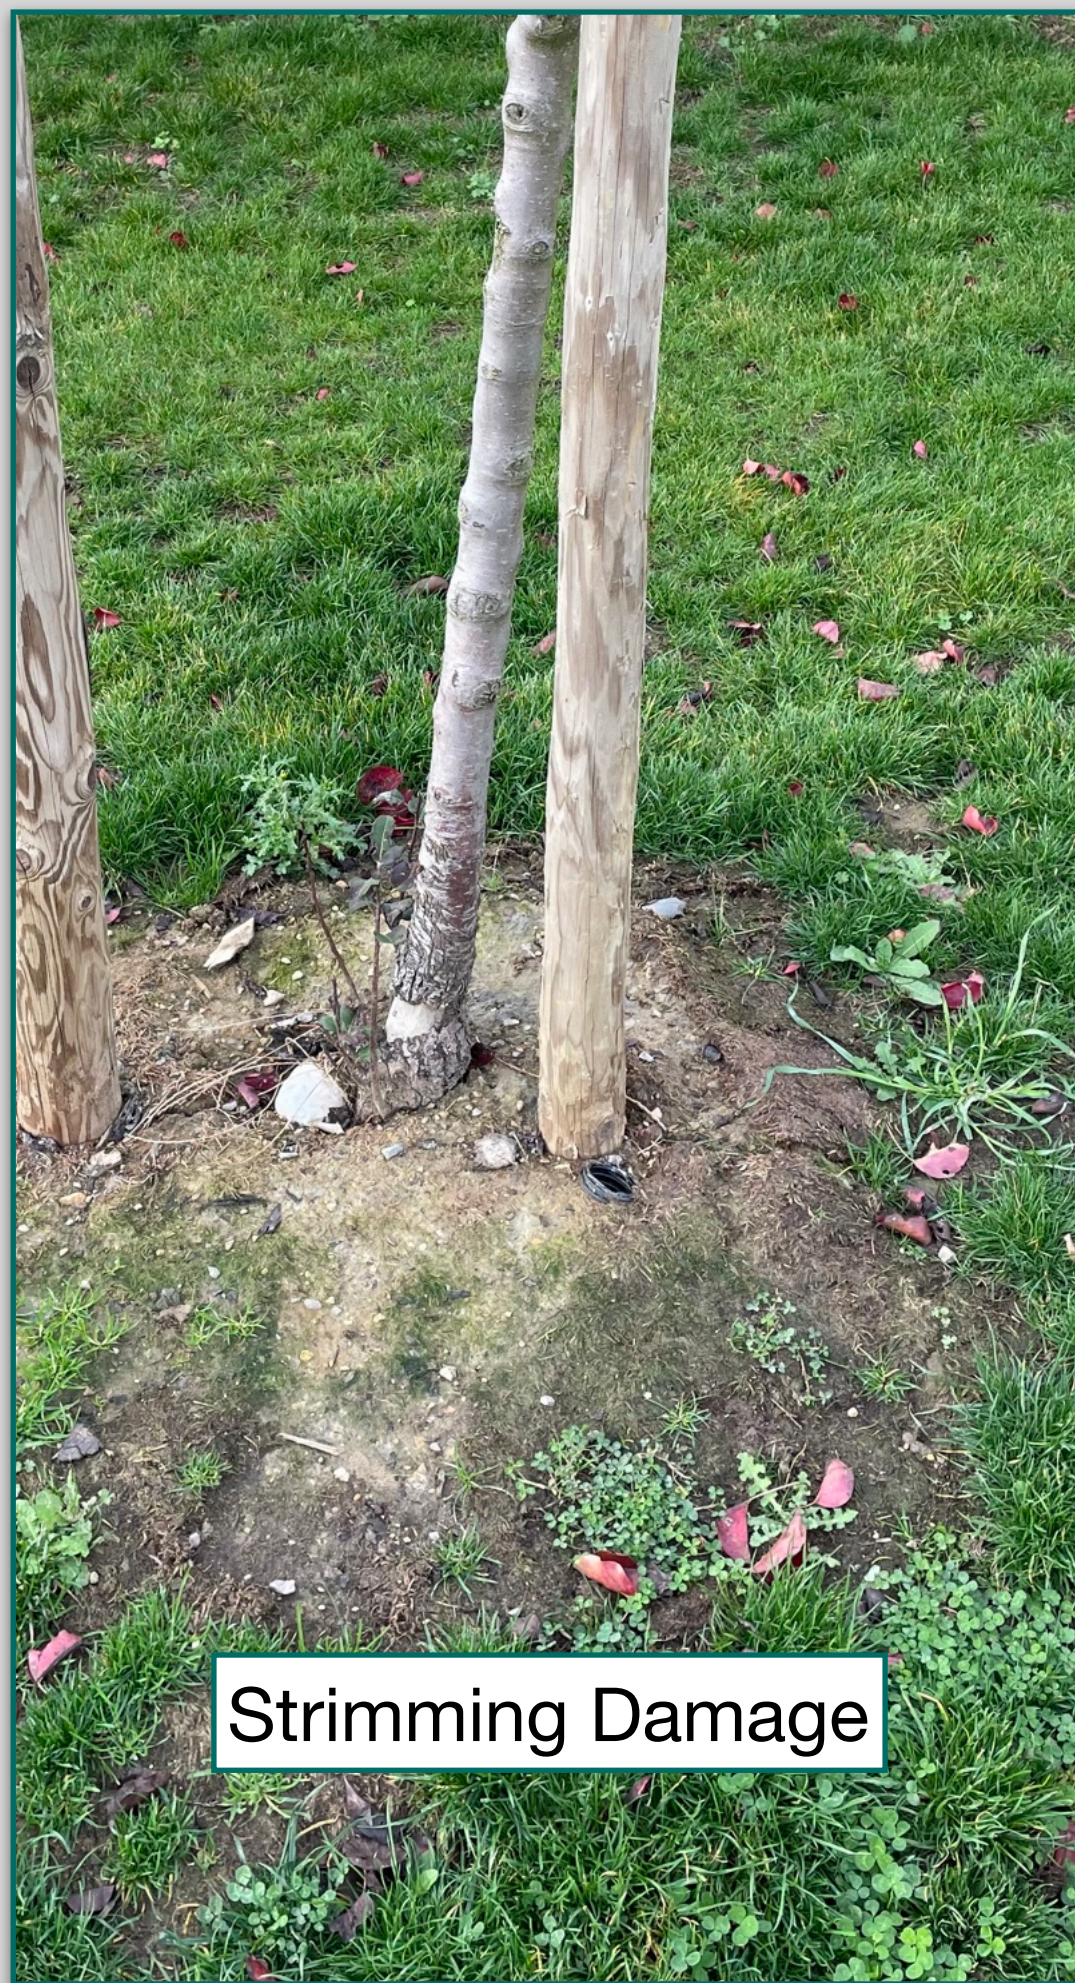
Poor Maintenance

Strimming Damage

Many young trees have had their bark damaged by strimmers.

This is serious and can kill the tree.

Even small areas of damage can weaken the tree or stunt its growth.

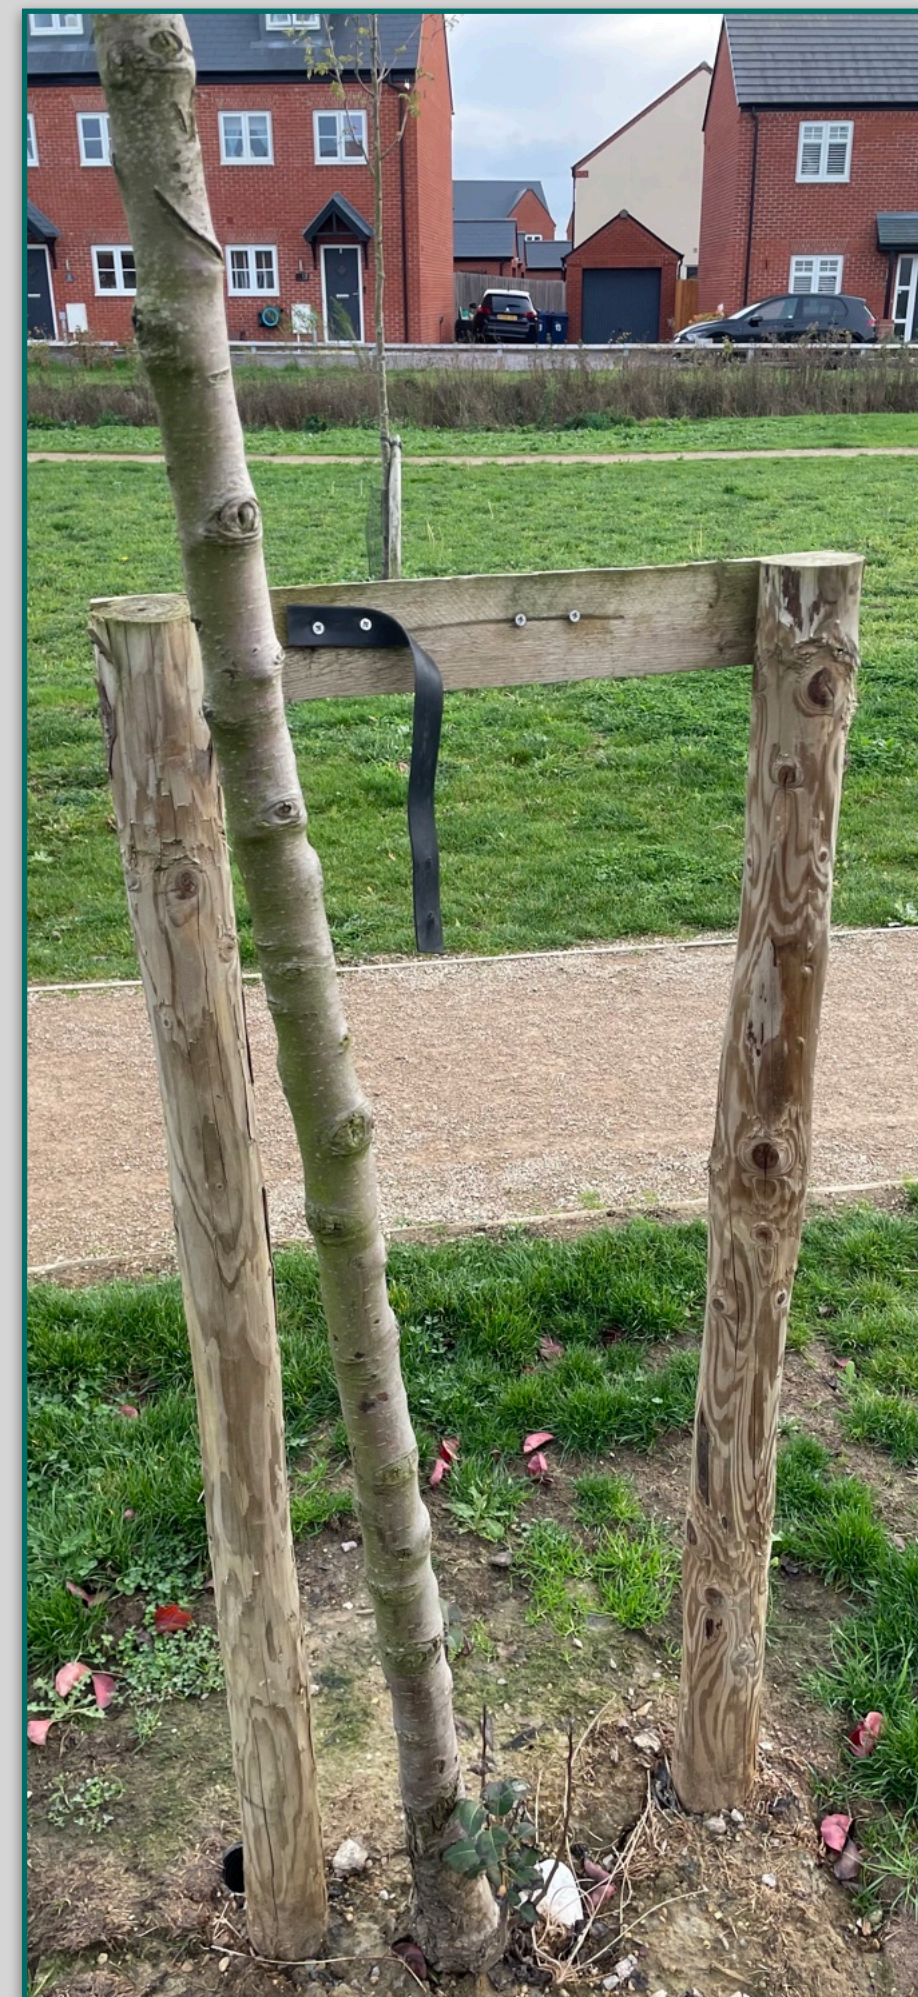
If a young tree loses its support straps:

- If it's strong enough, it will stay upright and grow stronger with the wind
- If it's not ready, it may lean, grow crooked, or even break

Likewise, straps or ties that are too tight will damage the young trees as they grow

Not paying attention to this has caused many trees to bend or snap
